UPDATED VEGETATION SURVEY REPORT FOR SLOPE MITIGATION WORKS

Agreement No. CE 8/2015 (WS)

First Stage of Desalination Plant at

Tseung Kwan O

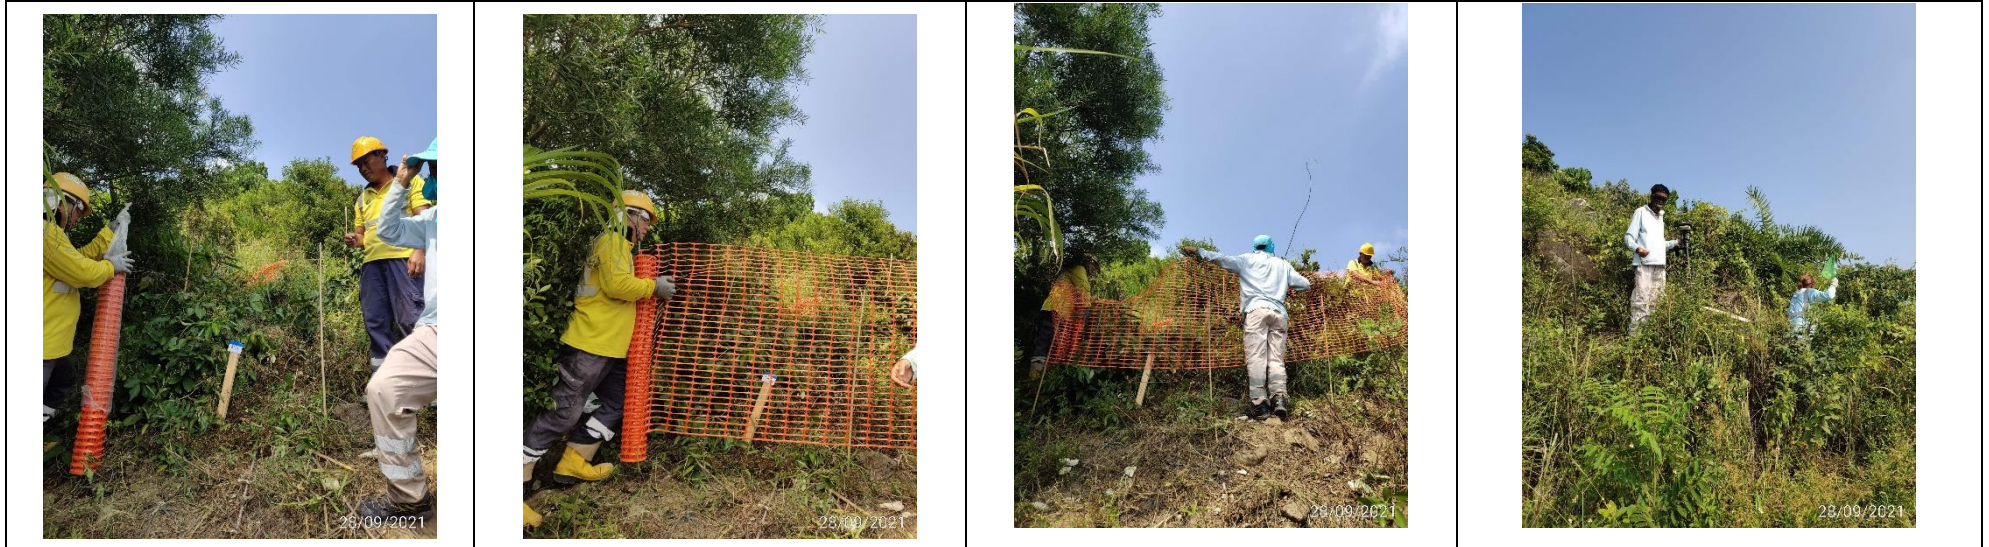
Plate 2. Work flow of setting up an eye-catching protection zone and setting GPS for plant species of conservation importance.

For the small vines of *Marsdenia lachnostoma*

For the larger patch of *Gnetum luofuense*

- 4.1.11 Another species of conservation importance, i.e., one patch of *Gnetum luofuense*, was found at terrain toe near the entrance of the transect. This patch of *Gnetum luofuense* has been fenced off by eye-catching protection zones under supervision of the plant specialist/ecologist to restrict unnecessary/accidental entry after commencement of works. The locations of the identified species of conservation importance are shown in Appendix G.
- 4.1.12 In summary, the 2021 survey recorded *Marsdenia lachnostoma* and *Gnetum luofuense* and no additional plant species of conservation importance were recorded.

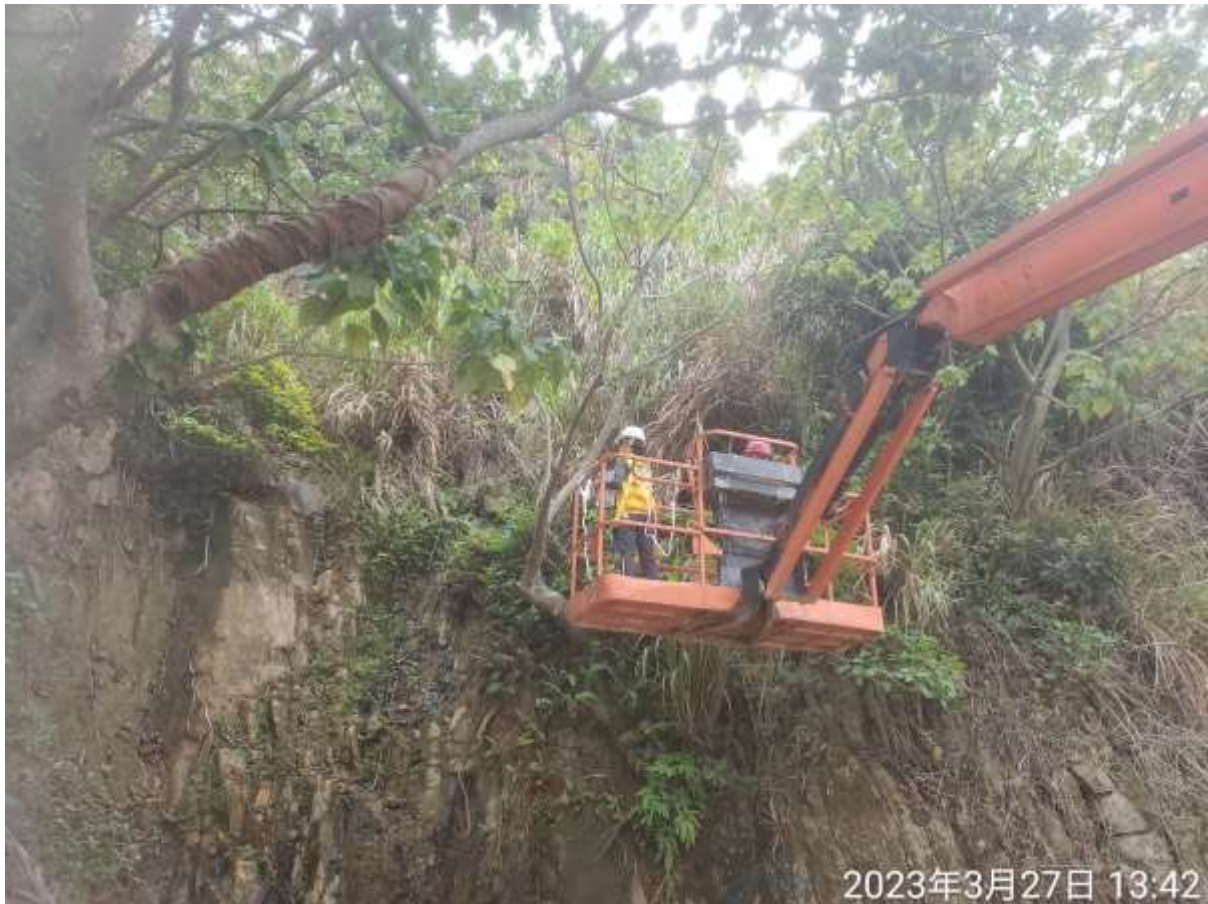
Figure 1 The upper part of the cliff area was assessed by cherry picker.
