Agreement No. CE 5/2019 (EP)
Independent Environmental Checker for First Stage of
Tseung Kwan O Desalination Plant – Investigation
Verification of Monthly EM&A Report No.17 (July 2021)

Design, Build and Operate First Stage of Tseung Kwan O Desalination Plant

Monthly EM&A Report No.17
(Period from 1 July to 31 July 2021)

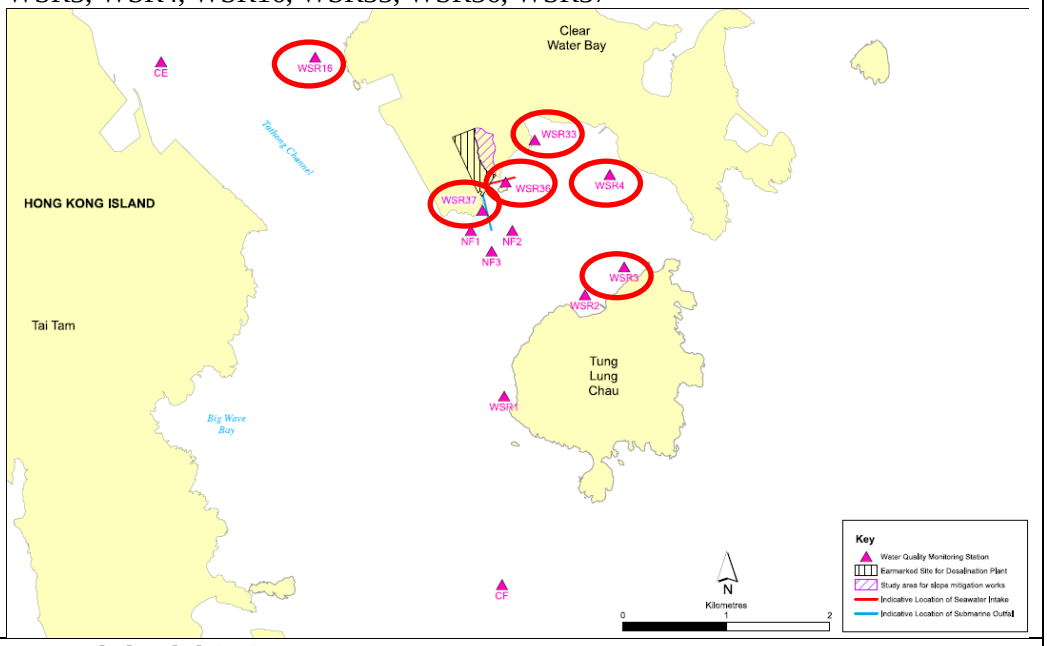
Supporting Photo 10 (SS level on 01 July 2021)

Locations	SS (flood average)	SS (ebb average)	SS (flood exceed)	SS (ebb exceed)
	WSR1	3.7	3.0	No	No
	WSR2	2.6	4.2	No	No
	WSR3	3.7	2.5	No	No
	WSR4	2.8	2.6	No	No
(ebb control)	CE	2.9	4.3		
(flood control)	CF	3.1	2.8		
	WSR16	2.9	3.3	No	No
	WSR33	3.5	2.5	No	No
	WSR36	2.5	2.5	No	No
	WSR37	5.9	2.5	Yes	No

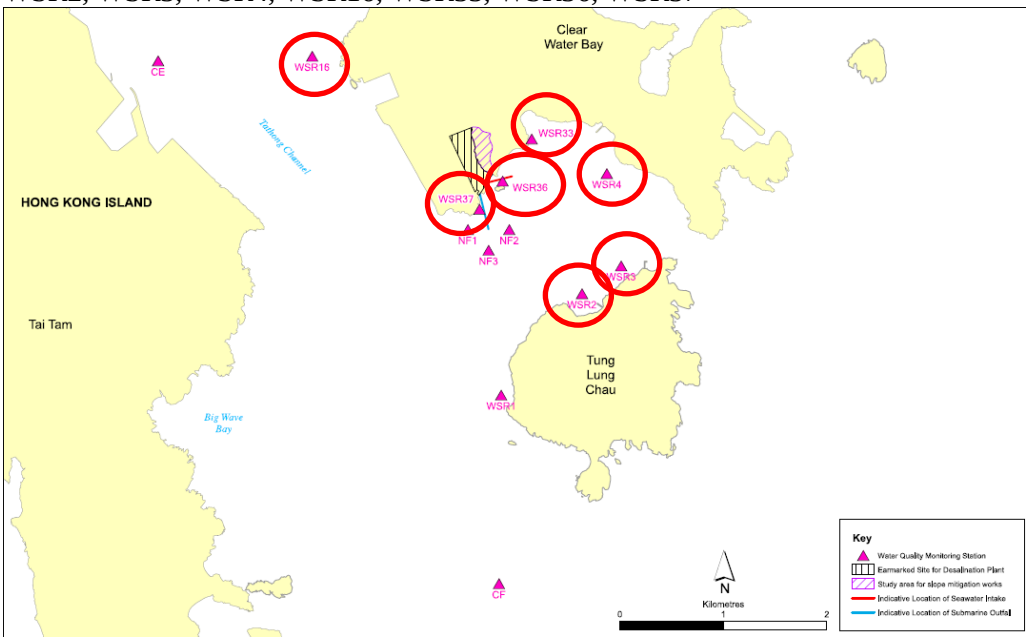
Supporting Photo 11 (SS level on 06 July 2021)

Locations	SS (flood average)	SS (ebb average)	SS (flood exceed)	SS (ebb exceed)
	WSR1	2.8	7.9	No	No
	WSR2	4.7	15.9	No	Yes
	WSR3	7.5	22.7	Yes	Yes
	WSR4	5.7	21.3	Yes	Yes
(ebb control)	CE	2.5	7.6		
(flood control)	CF	2.7	7.3		
	WSR16	7.5	20.8	Yes	Yes
	WSR33	7.2	22.0	Yes	Yes
	WSR36	6.9	21.8	Yes	Yes
	WSR37	7.1	23.9	Yes	Yes

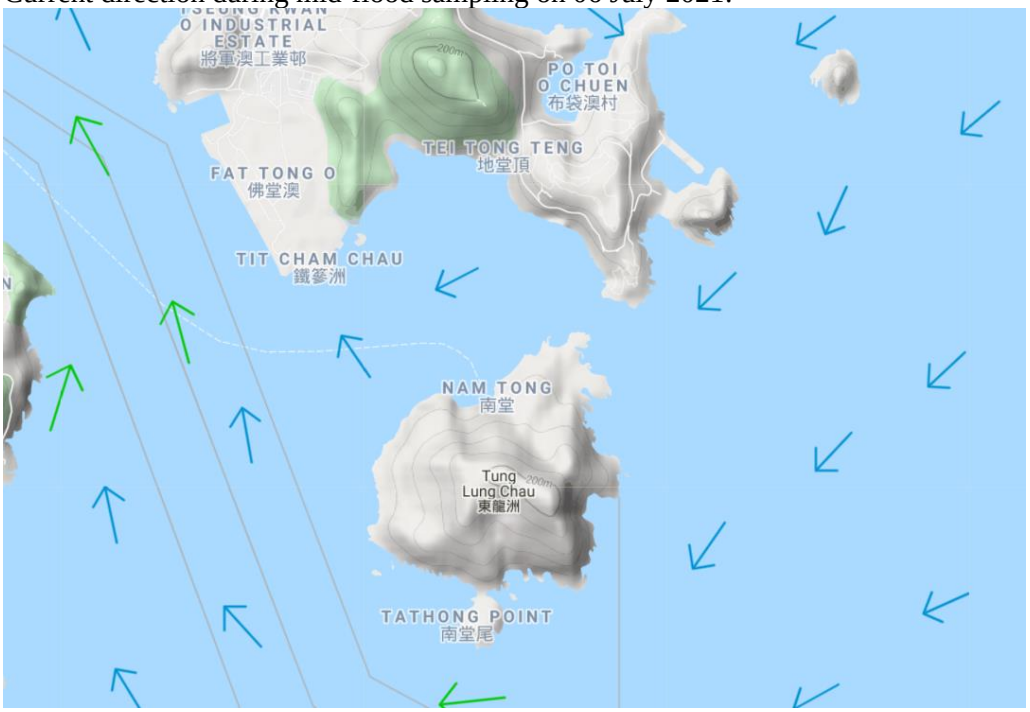
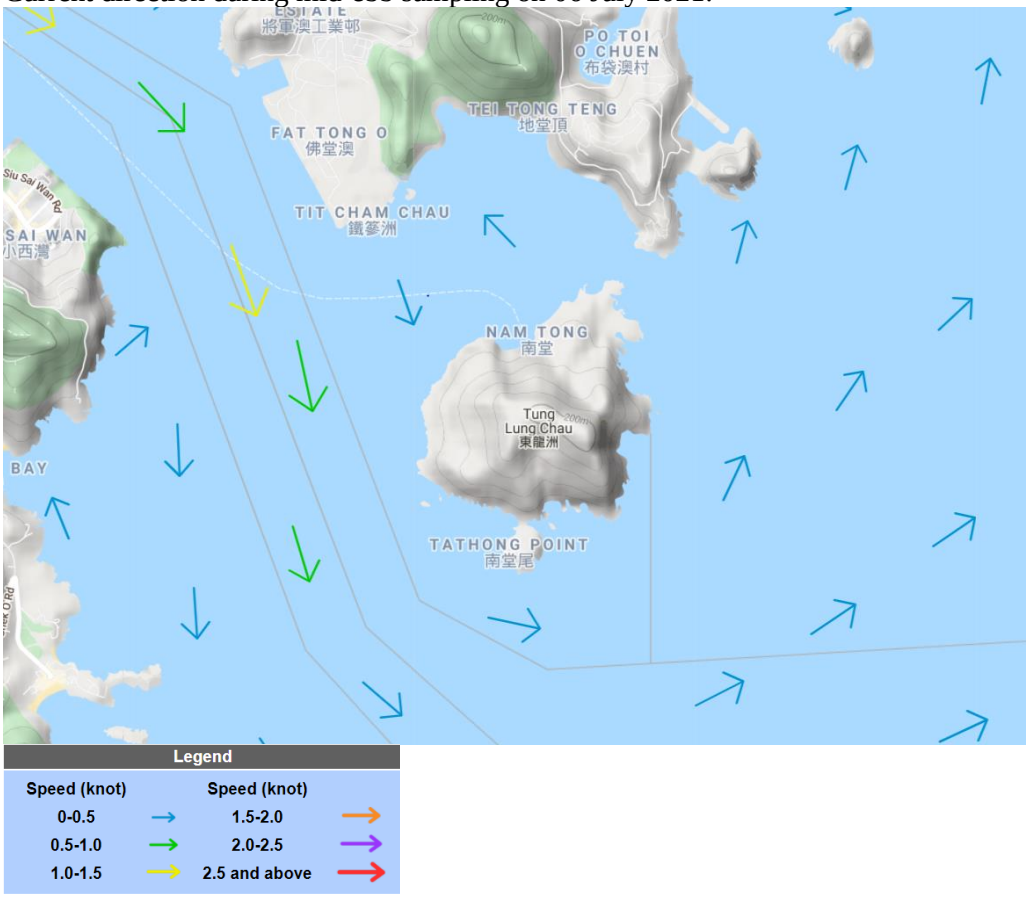
<table><tr><td></td><td colspan="3">As been advised by the Main Contractor, no dredging activities was conducted at WSR37 on 06 July 2021. Since it is expected that dredging activities will generate high SS, the SS value at WSR37 infers other factors may have caused the elevated SS value. The SS level at WSR37 (7.1 mg/L) was also higher than WSR36 (6.9 mg/L), where no dredging activities was conducted at WSR37. The SS level of an upstream location, WSR3 (7.5 mg/L), was higher than WSR36, where marine construction works were observed. In view of the inverse relation between sea current direction and SS level, the SS exceedance is concluded not project relevant. The SS levels of upstream locations, i.e. WSR3 (7.5 mg/L), WSR4 (5.7 mg/L) and WSR33 (7.2 mg/L), have all exceeded the Action Level (5.0 mg/L), implying that SS had resulted from other source(s).
Tropical cyclone warning signal no.1 was issued on 06 July 2021 with accumulative rainfall reaching 30mm over Joss-House Bay (Tai Miu Wan). The rainfall may lead to release of SS content from the soil of the nearby lands (e.g. country park, fill bank). The SS data during mid-flood tide suggested unstable weather conditions may be the dominating factor of elevated SS value of which all monitoring stations in the Joss House Bay have reached 20-24 mg/L on 06 July 2021.
According to the field observation by sampling team during sampling event, no silt plume was observed in the Project site on 06 July 2021.
Conditions of the protective silt curtain at the inland water outfall and Outfall Shaft Area was satisfactory on 06 July 2021.</td></tr></table>

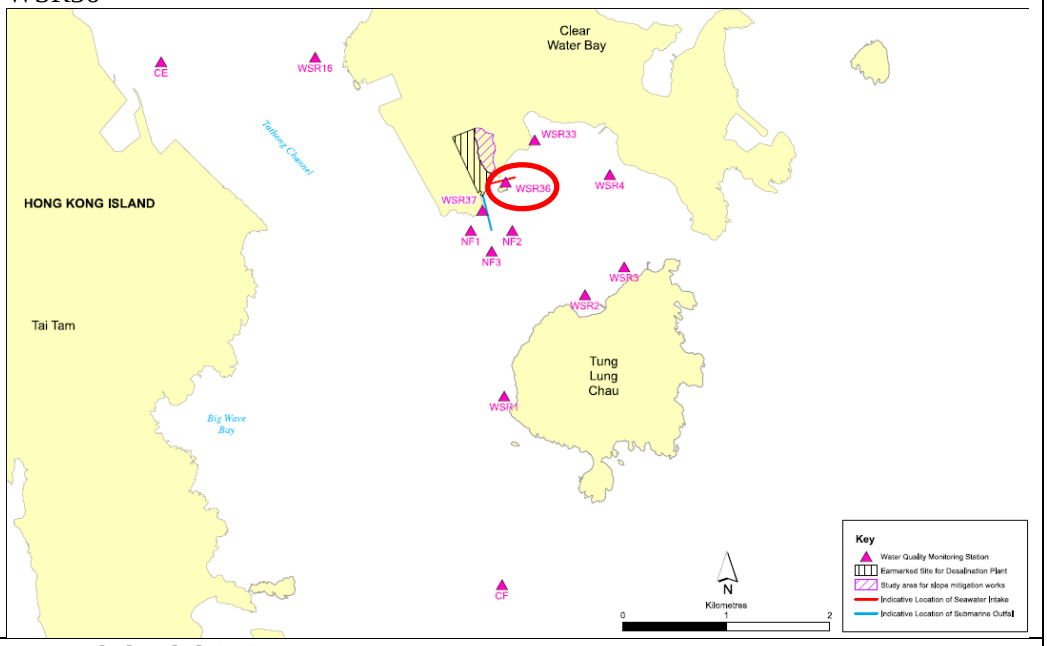
Supporting Photo 6 (Silt Plume and Landslide near to Coastline of Clear Water Bay Country Park at WSR36)
