Contract No. 13/WSD/17

Design, Build and Operate First Stage of Tseung Kwan O Desalination Plant

Monthly EM&A Report No.47
(Period from 1 January to 31 January 2024)

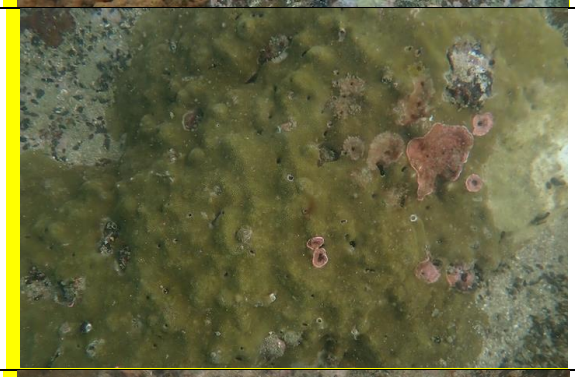
Photo Plate A Tagged Corals at Control Site C8

4.2. No sediment, bleaching or increased mortality in the general condition of all other tagged coral colonies were observed during the pre-operation phase monitoring period. No deterioration of the coral community was observed in the ecological monitoring results when compared with the baseline ecological monitoring results. There is no AL/LL exceedance during the monitoring period. Photos of each tagged corals colonies were taken and shown in Appendix A (Photo Plates A, B and C).

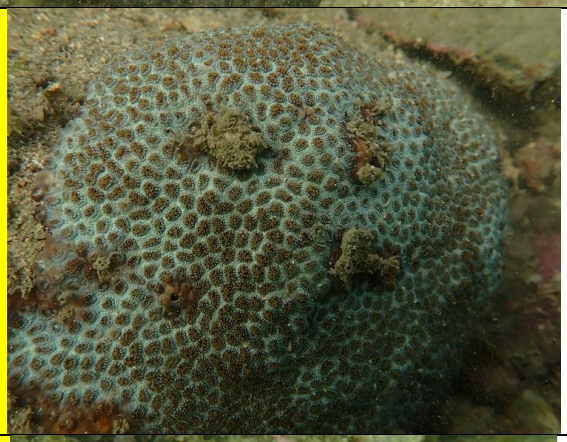
7.6. Pre-operation phase coral monitoring works was conducted on 30 January 2024. All tagged coral colonies showed good health condition during the January 2024 Monitoring survey. There was no increased level of mortality, bleaching and sediment in other tagged coral colonies when compared with the baseline results. There is no AL/LL exceedance during the monitoring period.
