Contract No. 13/WSD/17

Design, Build and Operate First Stage of Tseung Kwan O Desalination Plant

Monthly EM&A Report No.50
(Period from 1 April to 30 April 2024)

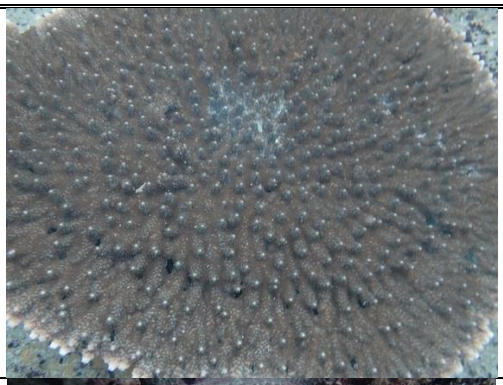
#5

4.2 No sediment, bleaching or increased mortality in the general condition of all other tagged coral colonies were observed during the monthly pre operation phase monitoring period. No deterioration of the coral community was observed in the ecological monitoring results when compared with the baseline ecological monitoring results. There is no AL/LL exceedance during the monitoring period. Photos of each tagged corals colonies were taken and shown in Appendix A (Photo Plates A, B and C).

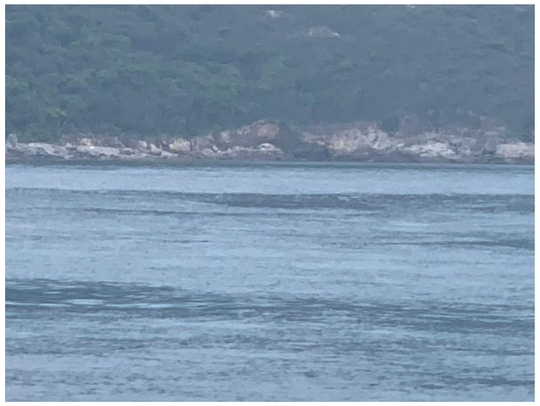
Date of exceedance	Monitoring station(s)			
02/04/2024

Supporting Photo:

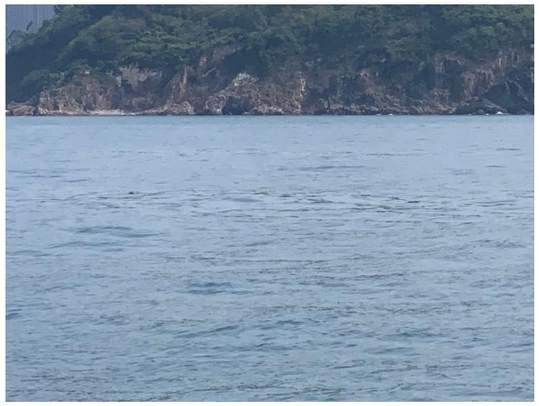
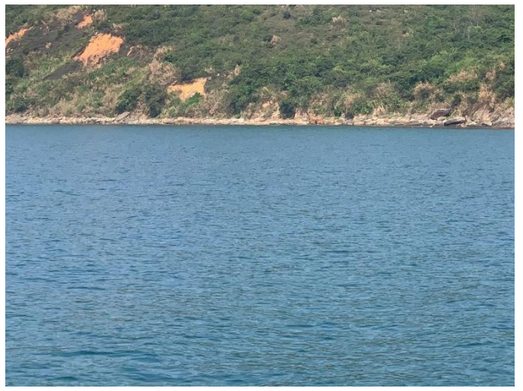
Date of exceedance	Monitoring station(s)			
16/04/2024

Supporting Photo:
