**Provision of Independent Environmental Checker (IEC) Service for Operation of the First Stage of Desalination Plant at Tseung Kwan O (Quotation Ref. No. TKO1/IEC/004)**

**Verification of Detailed Design Plan for Slope Mitigation Works (Issue 9)**

Referring to the Detailed Design Plan for Slope Mitigation Works (190495/29.2140 Issue 9) as submitted on 6 May 2026, we hereby verify the captioned report for further submission to the Director's Representative of the Project according to Clause 2.8 of the Environmental Permit EP-503/2015/B and Further Environmental Permit FEP-01/503/2015/B.

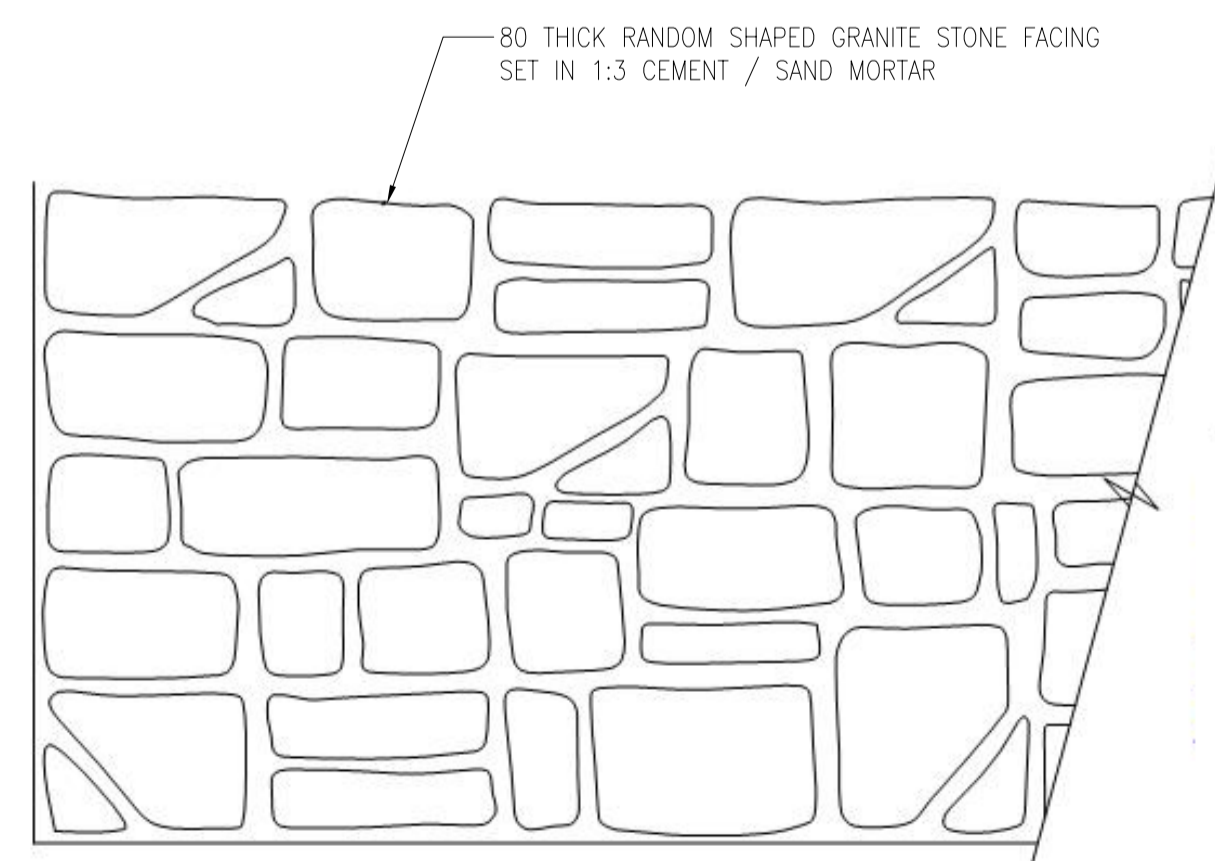
ELEVATION OF STONE FACING (RANDOM PATTERN)

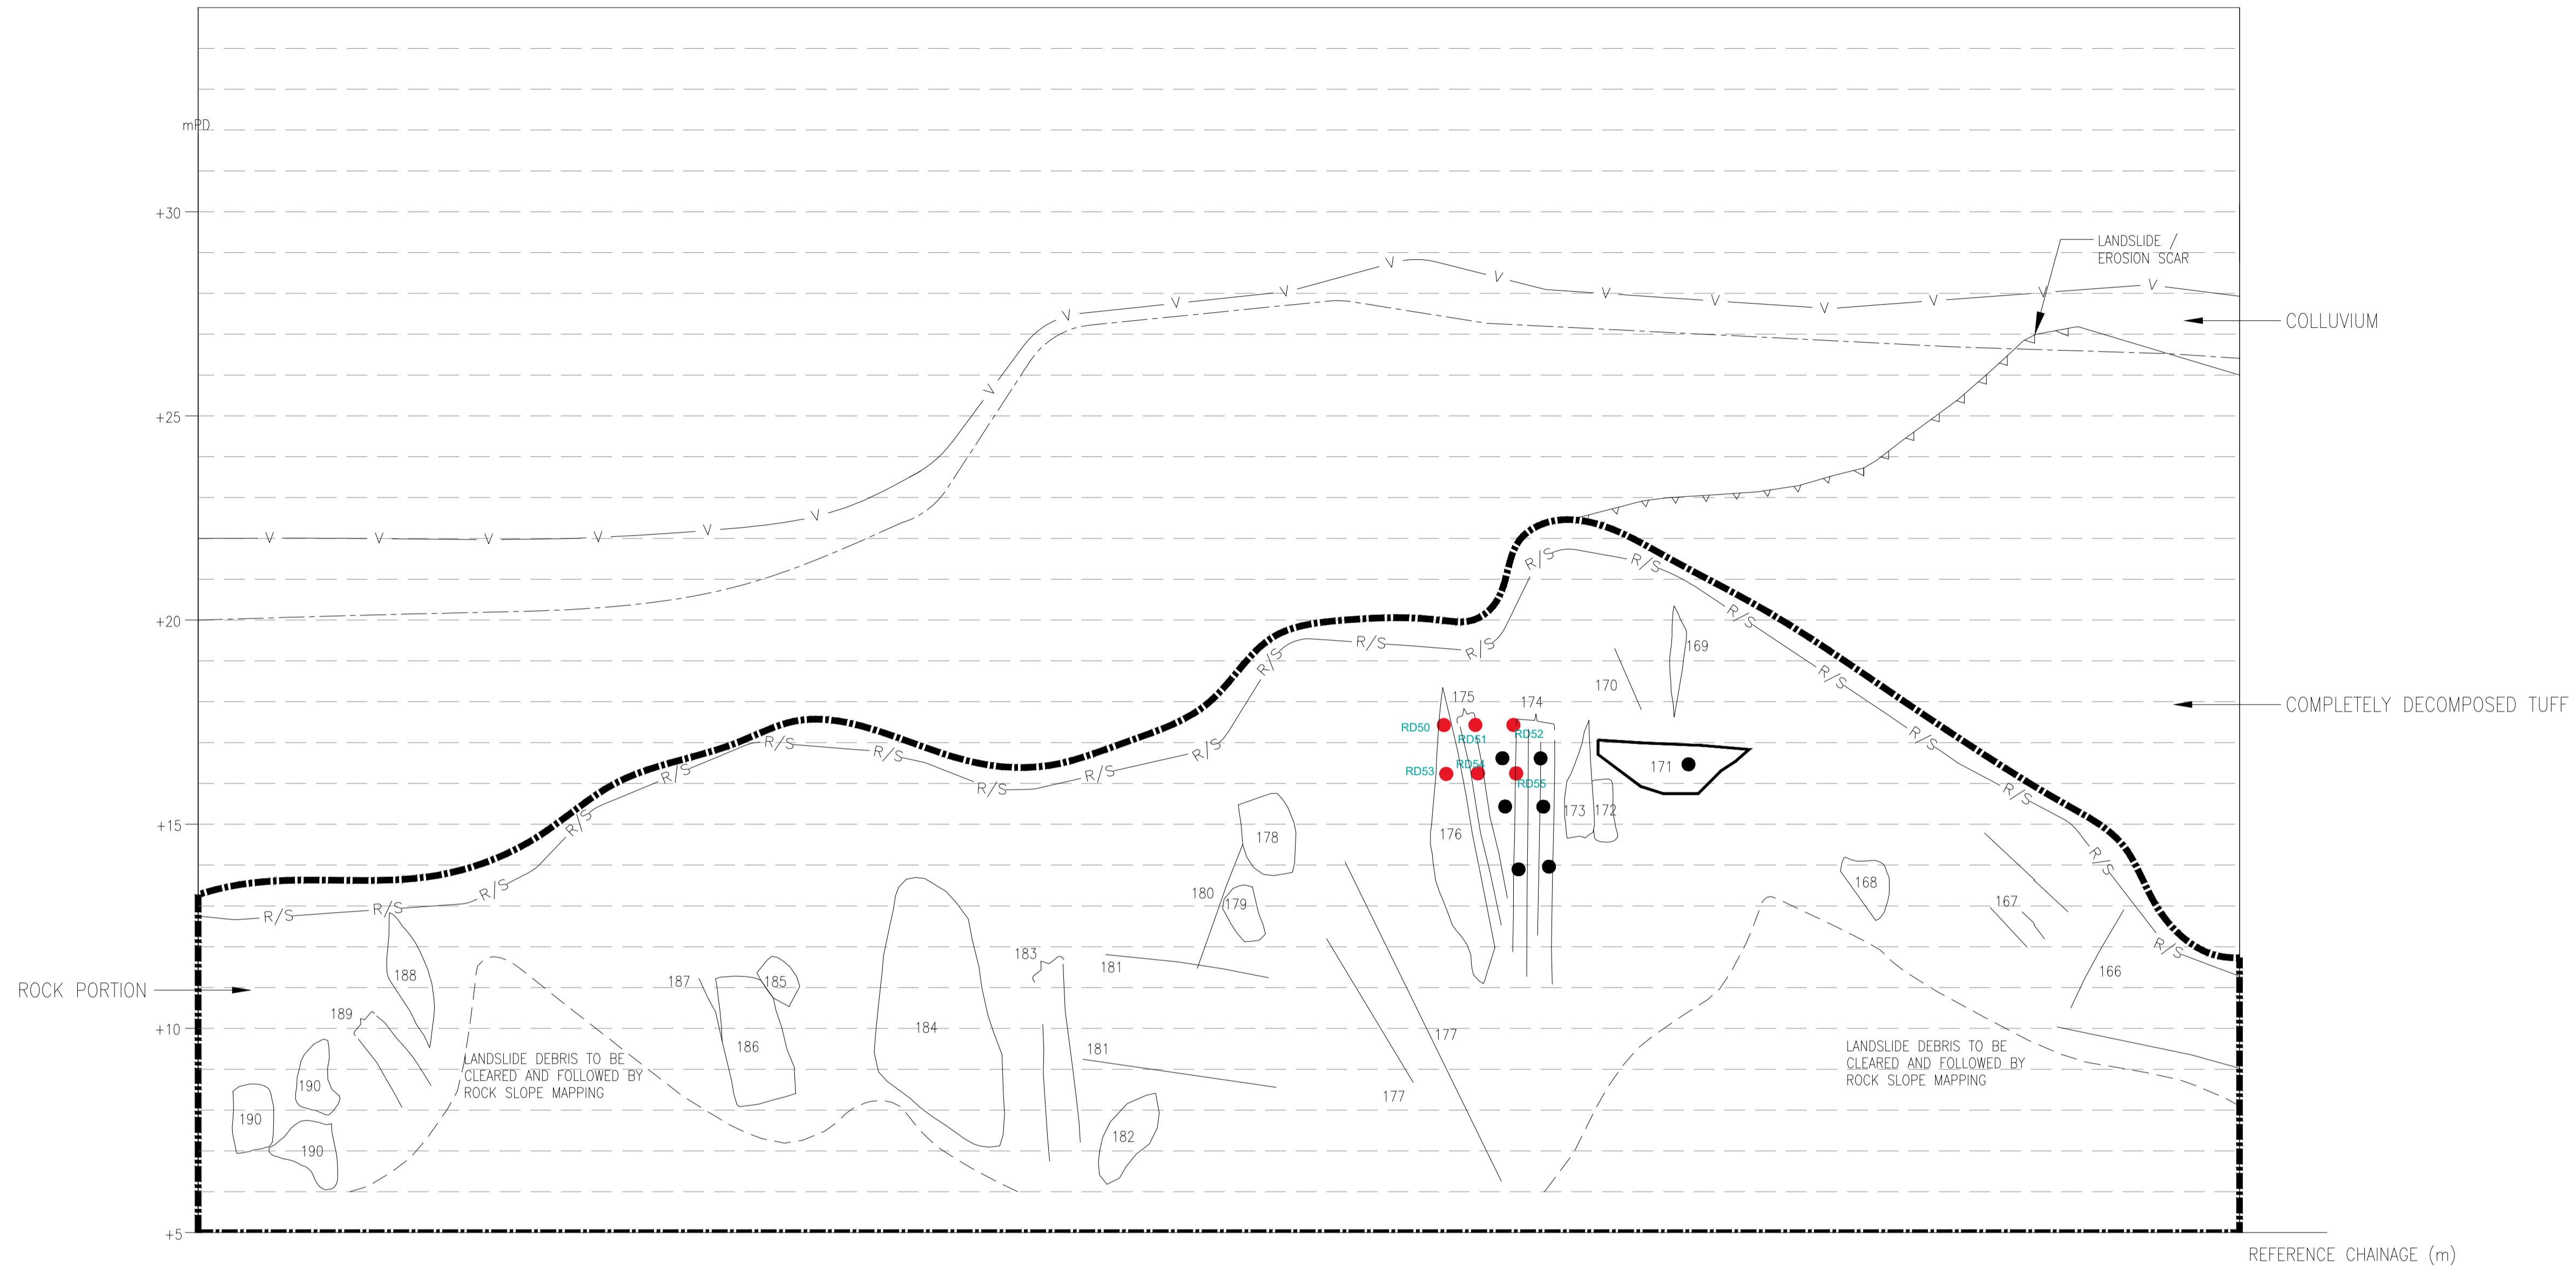
Drawing No. 190495/K/TEND/80/2006	Revision -
--------------------------------------	---------------

ELEVATION  
SCALE A1 1:100  
A3 1:200

- LEGEND:
- REVISED WIRE MESH LOCATION
  - REVISED ROCK DOWEL LOCATION
  - REVISED BUTTRESS LOCATION
  - ORIGINAL WIRE MESH LOCATION
  - ORIGINAL ROCK DOWEL LOCATION
  - ORIGINAL BUTTRESS LOCATION
  - ORIGINAL DENTITION LOCATION
  - POTENTIAL UNSTABLE ROCK BLOCK AS OBSERVED ON SITE (INDICATIVE)
  - POTENTIAL UNSTABLE ROCK BLOCK AS OBSERVED ON SITE WITH PROPOSED SCALING (INDICATIVE)
