Contract No. 13/WSD/17

**Design, Build and Operate First Stage of Tseung Kwan O
Desalination Plant**

**Quarterly EM&A Report No.17
(Period from 1 March 2024 to 31 May 2024)**

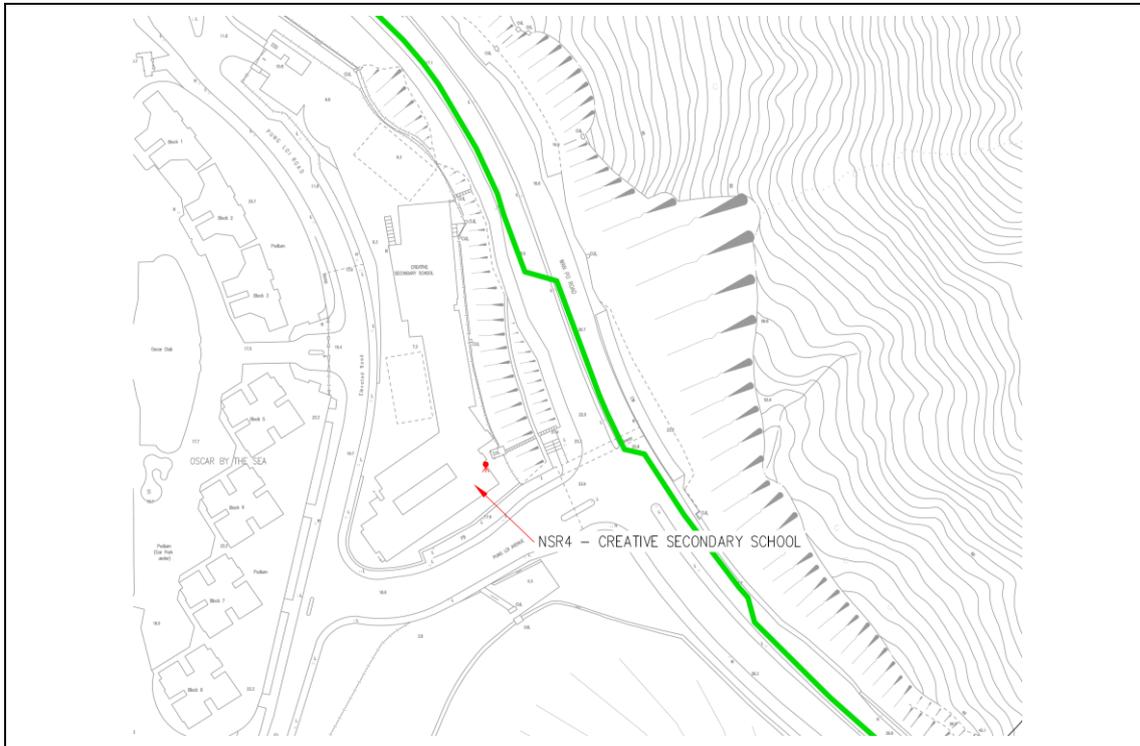
Figure 2.1 NSR4 Creative Secondary School

The monitoring locations should normally be made at a point 1m from the exterior of the NSRs building façade and be at a position 1.2m above the ground. A correction of +3dB(A) should be made to the free-field measurements. Three noise monitoring locations for impact monitoring at the nearby sensitive receivers are shown in **Figure 2.1-2.3**.

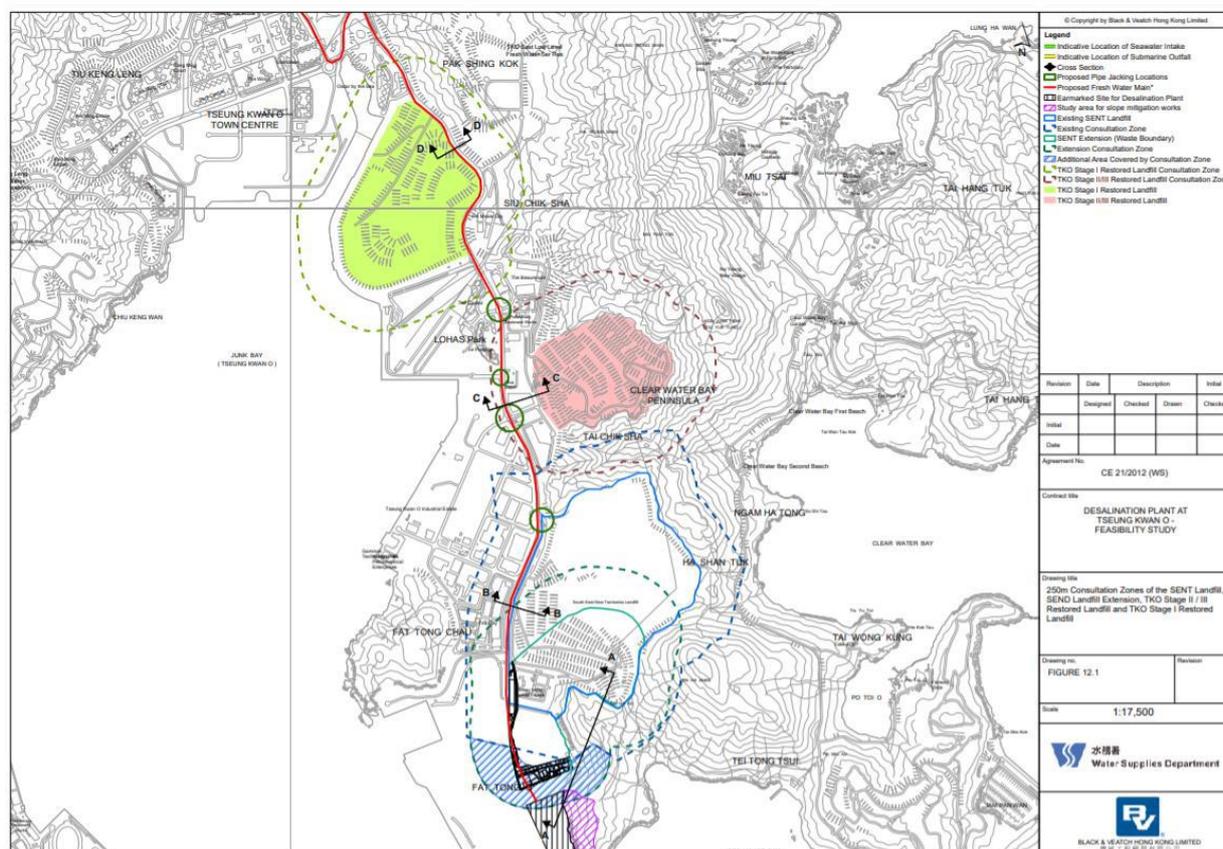
Figure 5.1 Overview of the SENT Extension Consultation Zone and the Project Site Area

The area required to be monitored for landfill gas in the reporting period is shown in **Figure 5.1**.

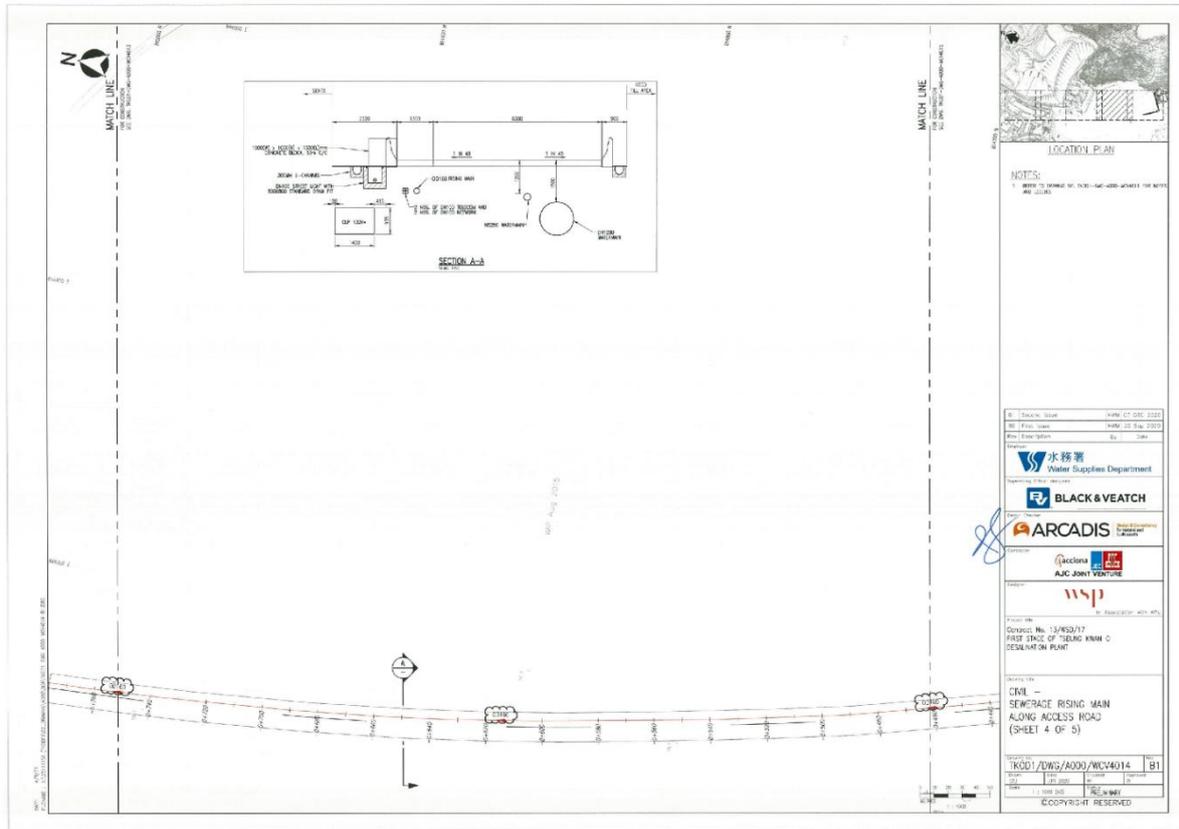
Figure 5.2 Location Map for Landfill Gas Monitoring at TKO Area 137 (-0+440 – -0+760)

In this reporting period, **372 times** of landfill gas monitoring were recorded at Wan Po Road (Ch0+390 – Ch0+780) and (Ch0+400 - Ch1+200). No exceedance of action and limit levels for methane, oxygen and carbon dioxide was observed. Monitoring was conducted during

excavations at 1m depth or more within the consultation zone and whenever workers entered the excavation on the day. The Location Map for Landfill Gas Monitoring at TKO Area 137 are shown in **Figure 5.2** and **5.3**.

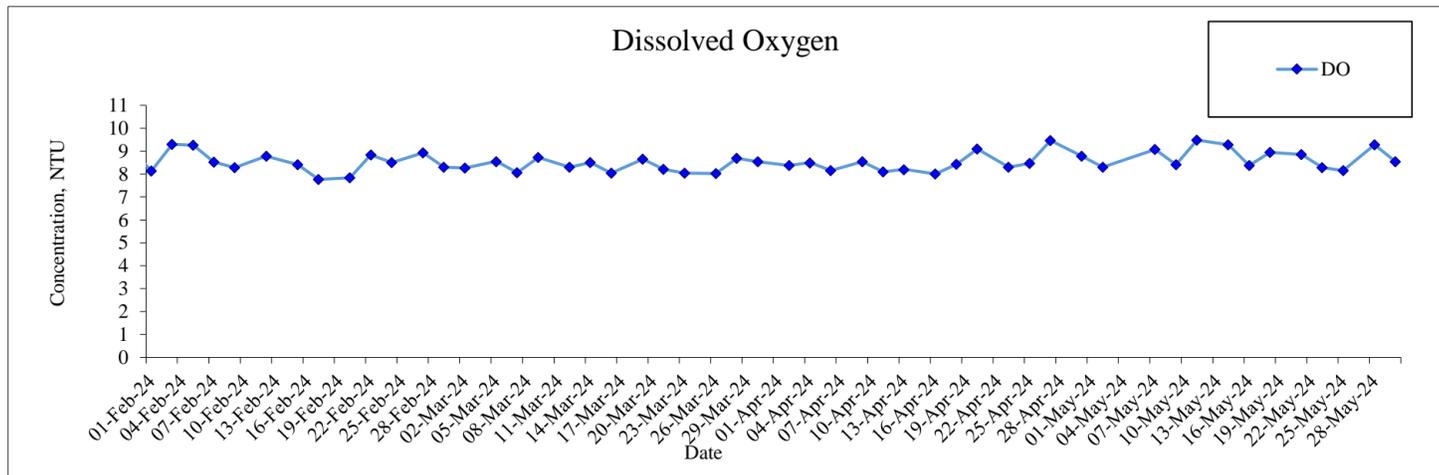
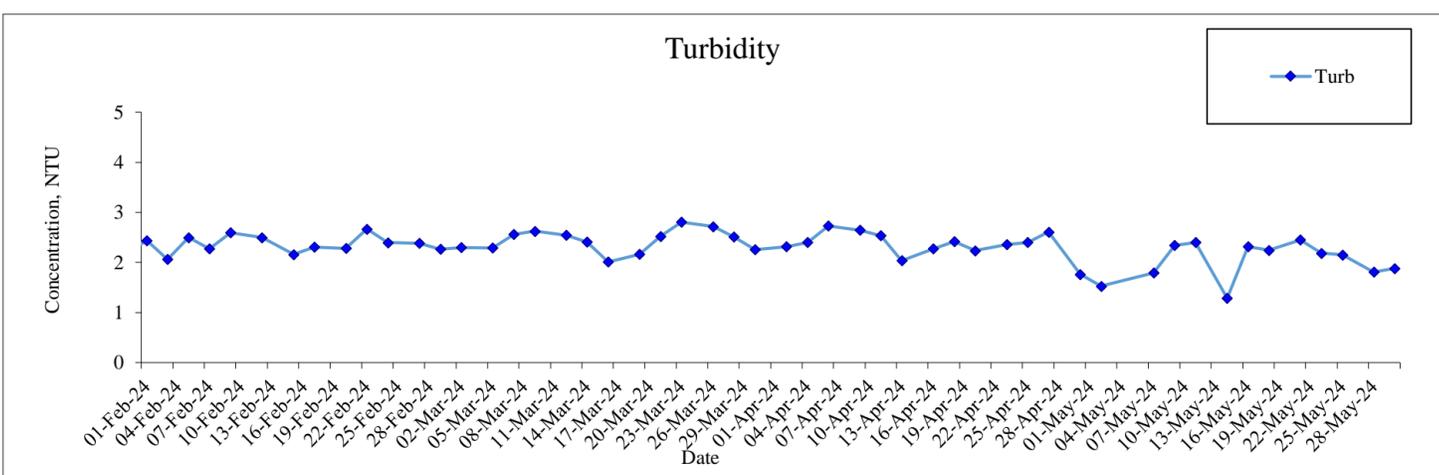
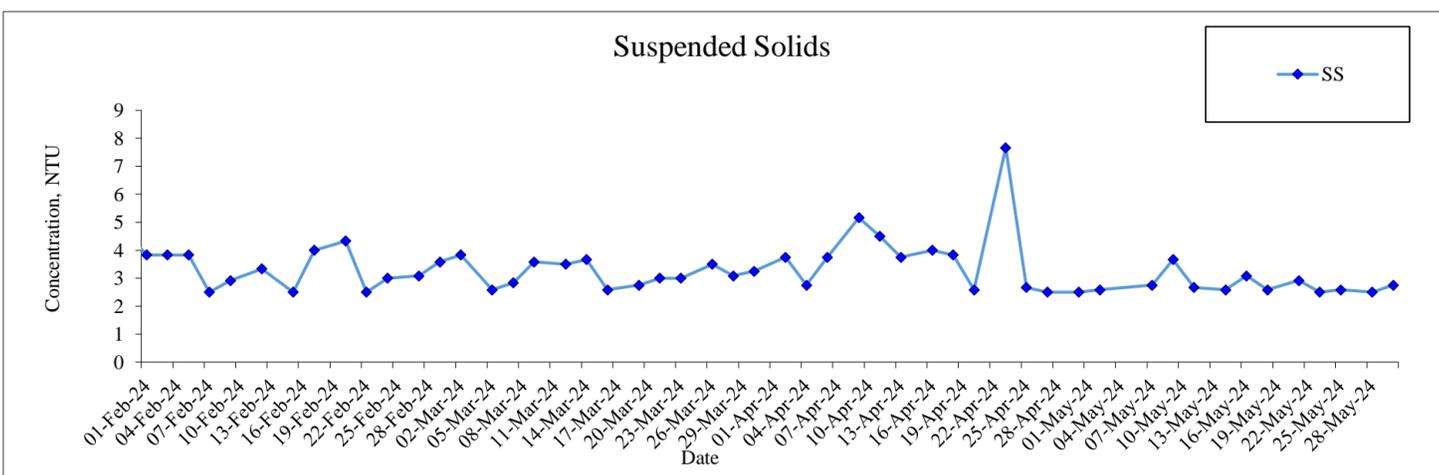
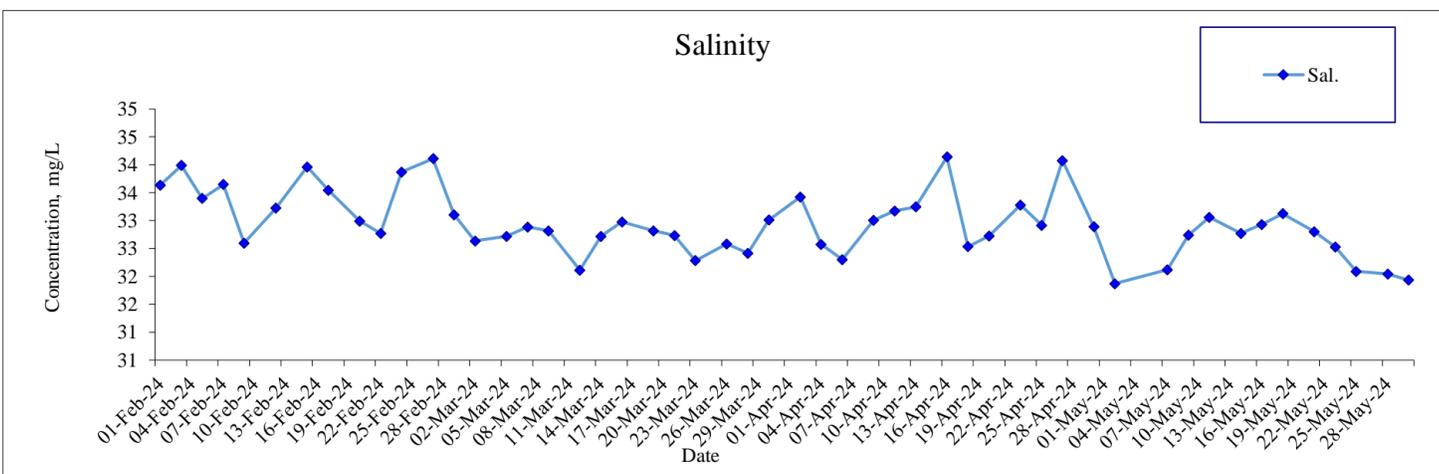
Monitoring Location: CE

Remark: The lowest detection limit of the Total Residual Chlorine is 0.01mg/L. All result of Total Residual Chlorine monitoring are lower than the detection limit.

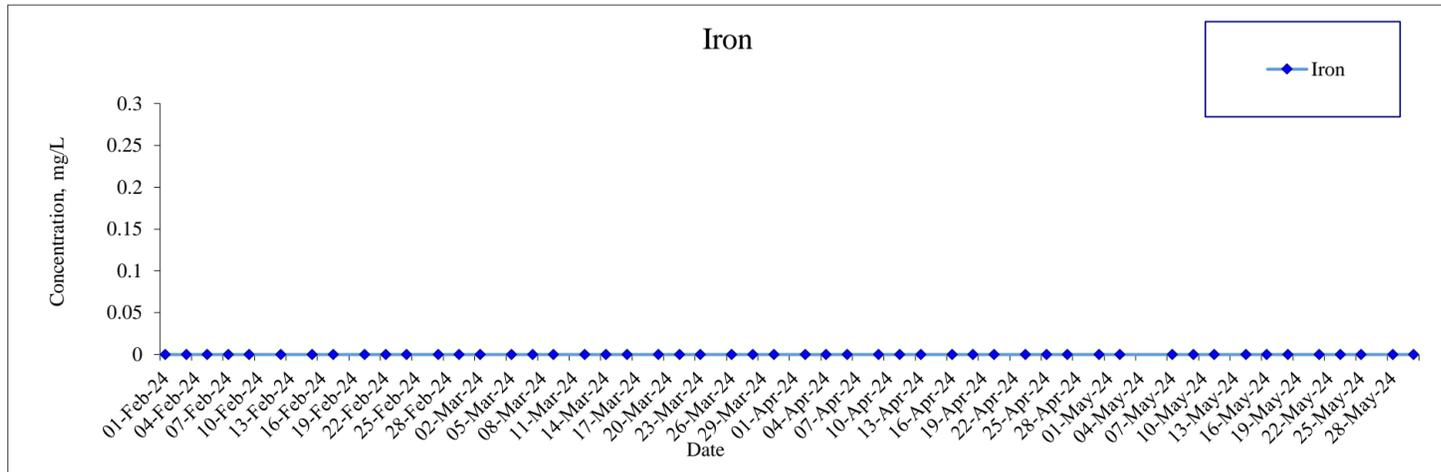
Monitoring Location: CE

Remark: The lowest detection limit of the Iron is 0.1mg/L. All result of iron monitoring are lower than the detection limit.

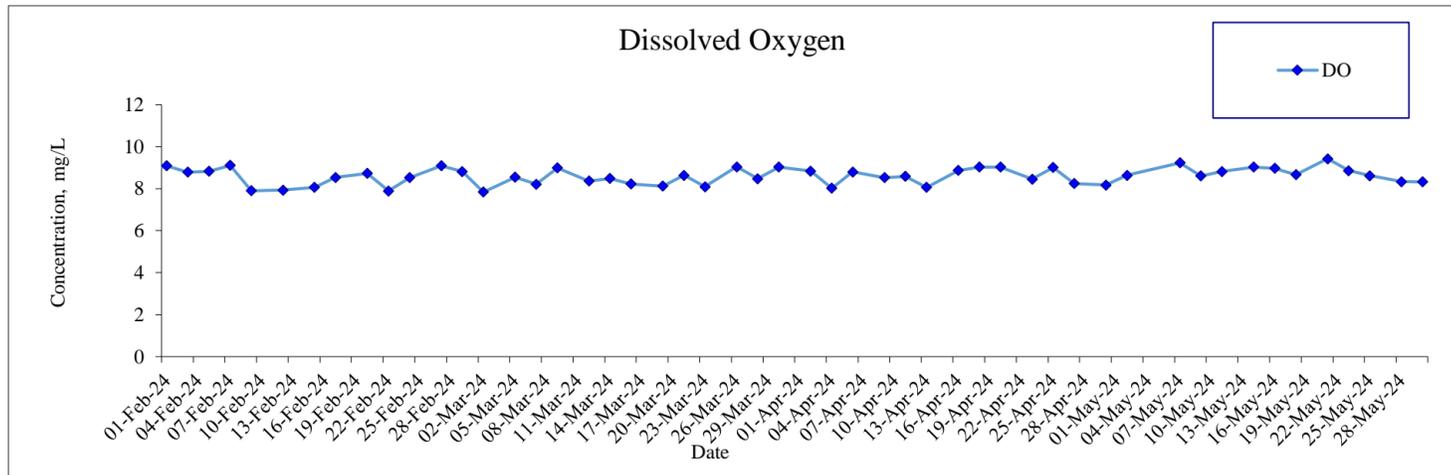
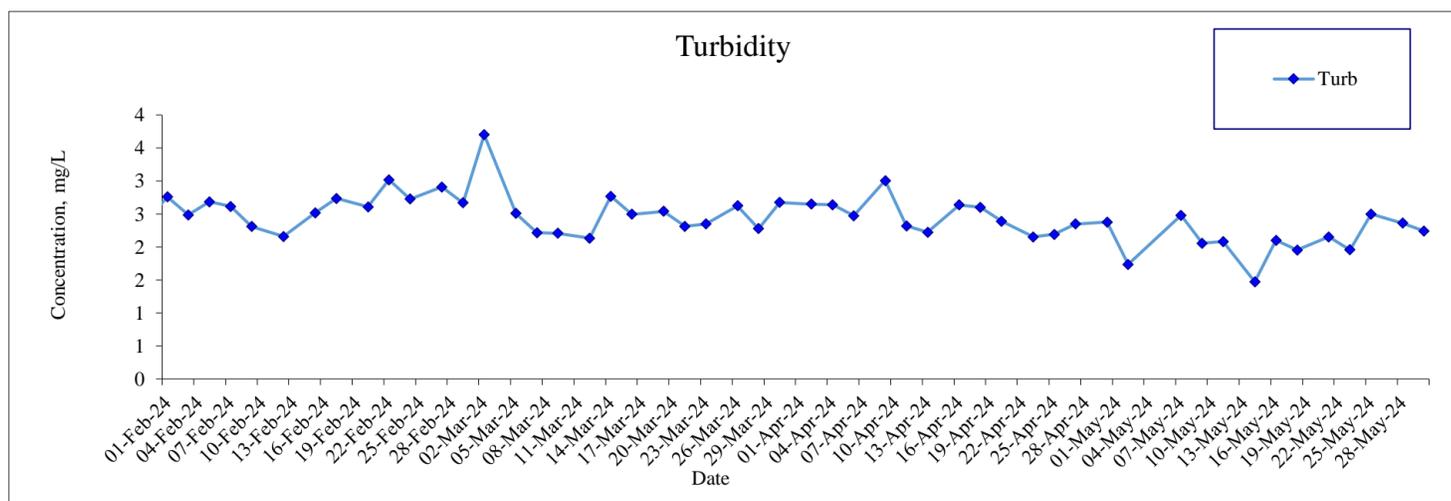
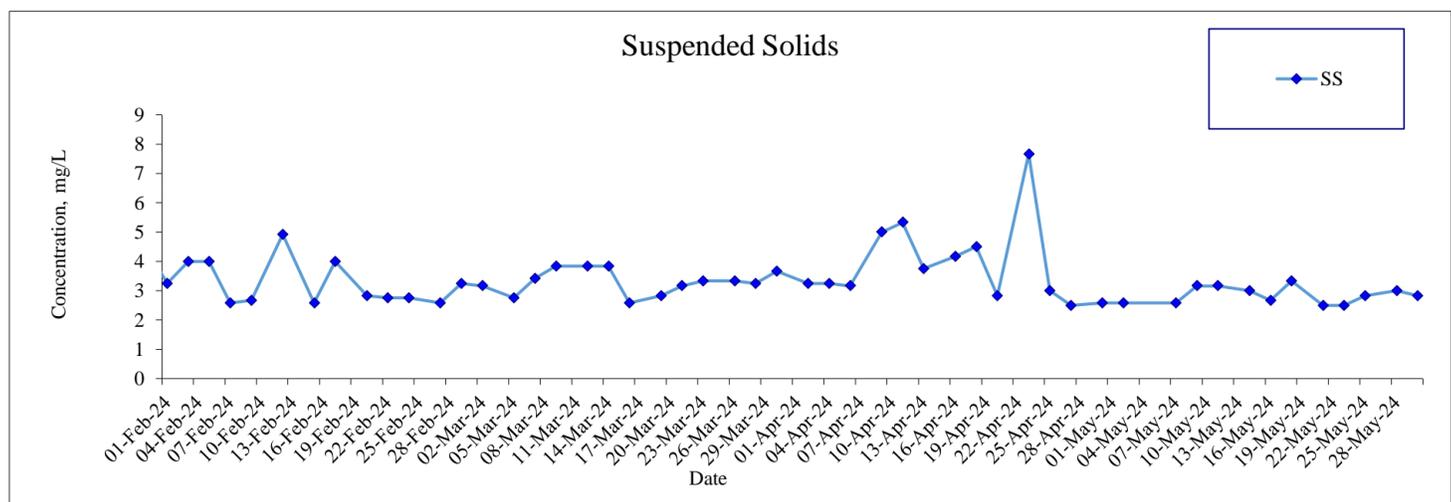
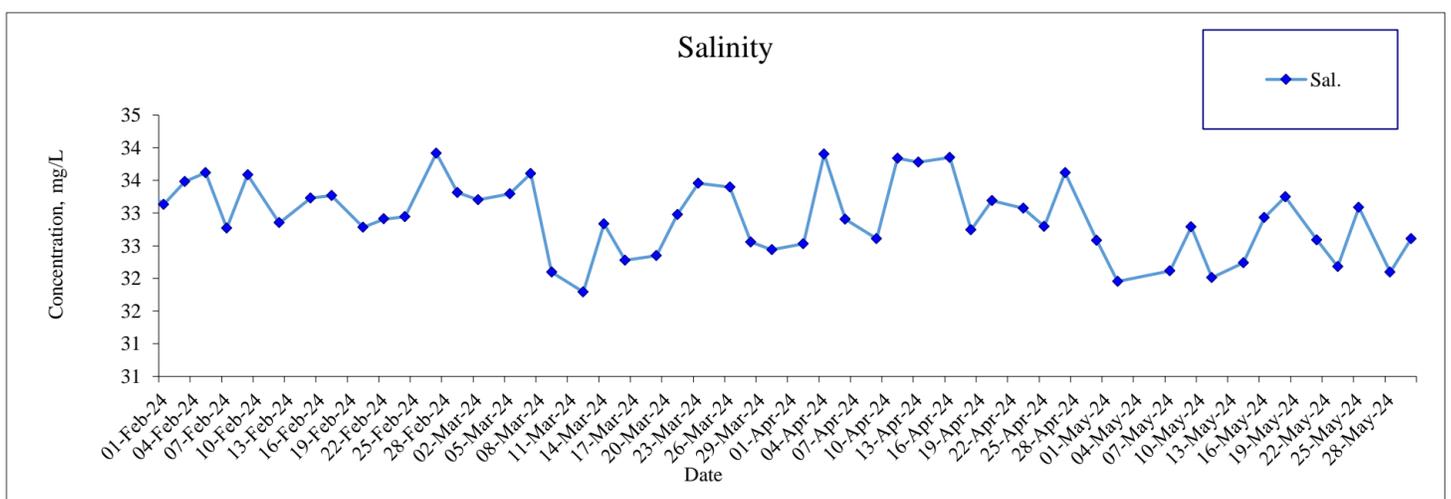
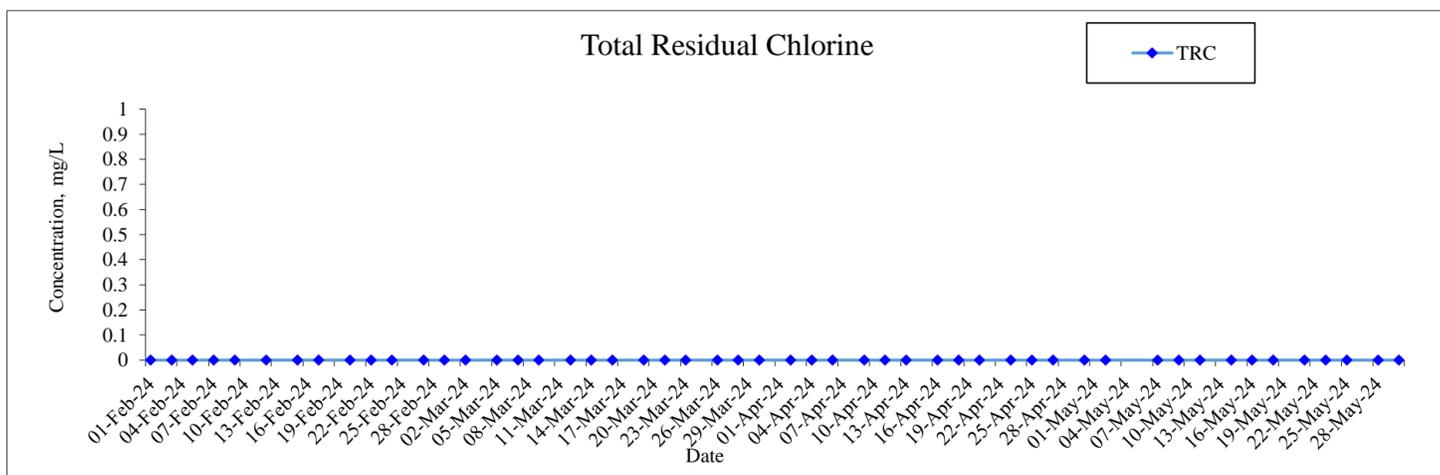
Monitoring Location: CF

Remark: The lowest detection limit of the Iron is 0.1mg/L. All result of iron monitoring are lower than the detection limit.

Remark: The lowest detection limit of the Total Residual Chlorine is 0.01mg/L. All result of Total Residual Chlorine monitoring are lower than the detection limit.

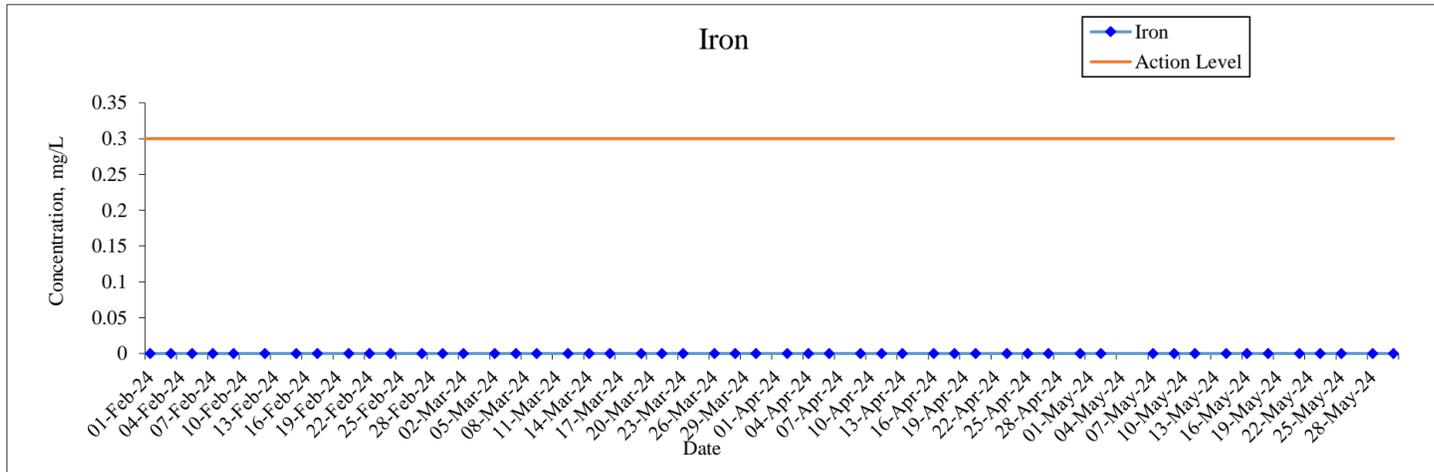
Monitoring Location: WSR1

Remark: The lowest detection limit of the Iron is 0.1mg/L. All result of iron monitoring are lower than the detection limit.

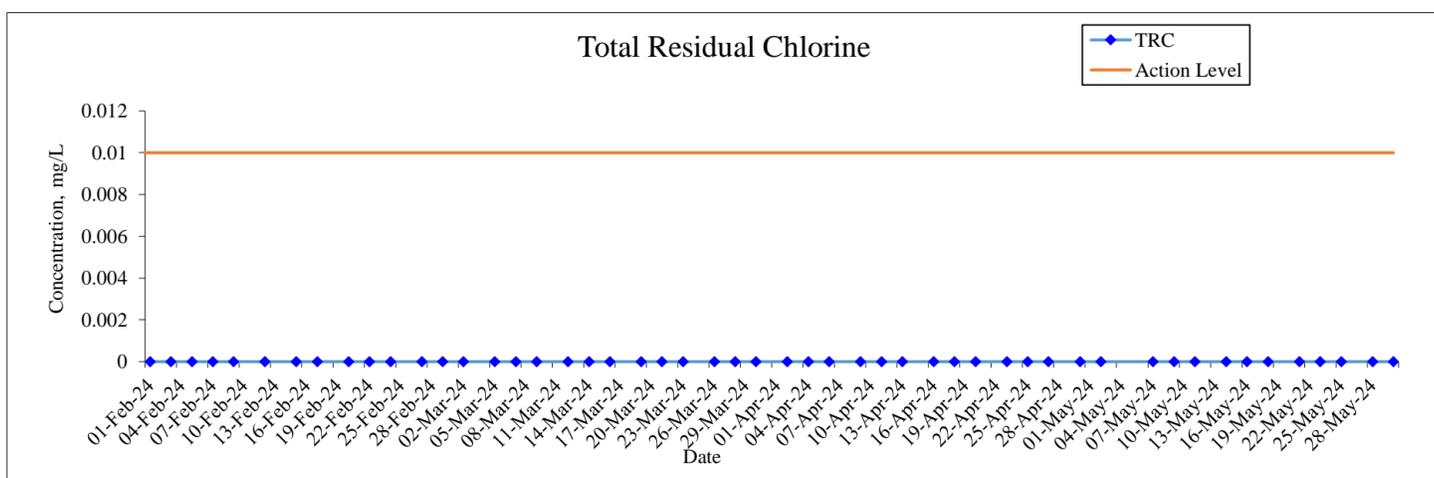
Remark: The lowest detection limit of the Total Residual Chlorine is 0.01mg/L. All result of Total Residual Chlorine monitoring are lower than the detection limit.

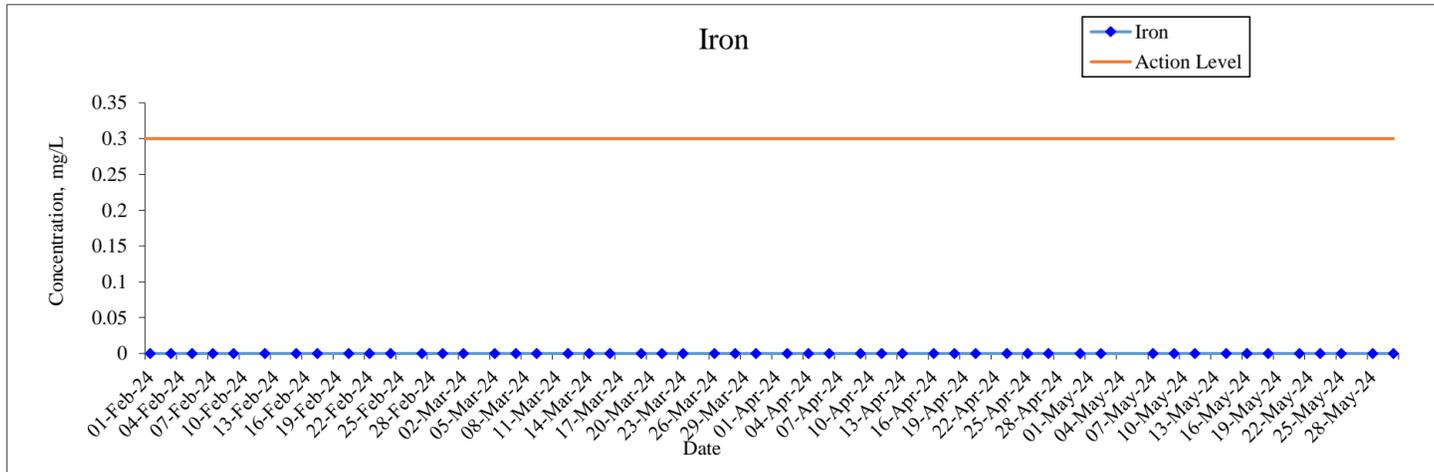
Monitoring Location: WSR2

Remark: The lowest detection limit of the Iron is 0.1mg/L. All result of iron monitoring are lower than the detection limit.

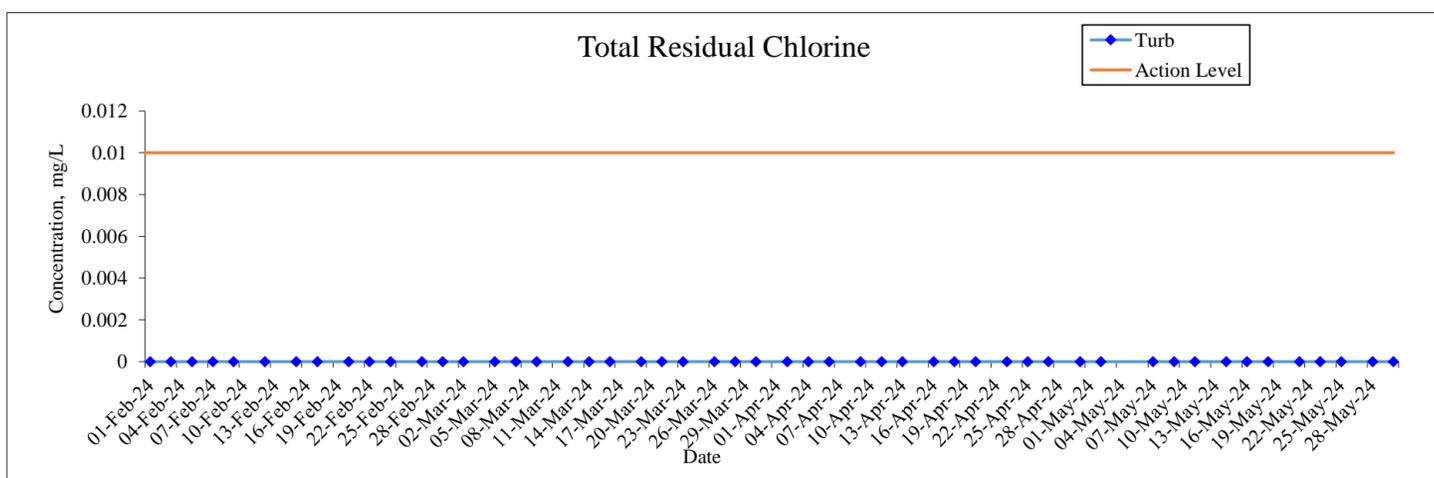
Remark: The lowest detection limit of the Total Residual Chlorine is 0.01mg/L. All result of Total Residual Chlorine monitoring are lower than the detection limit.

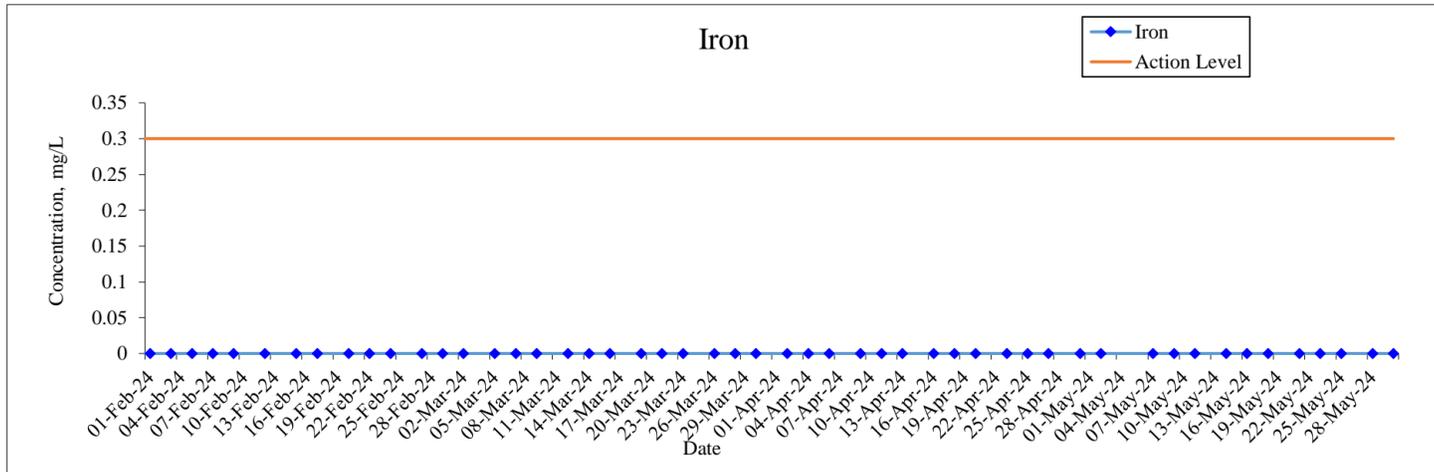
Monitoring Location: WSR3

Remark: The lowest detection limit of the Iron is 0.1mg/L. All result of iron monitoring are lower than the detection limit.

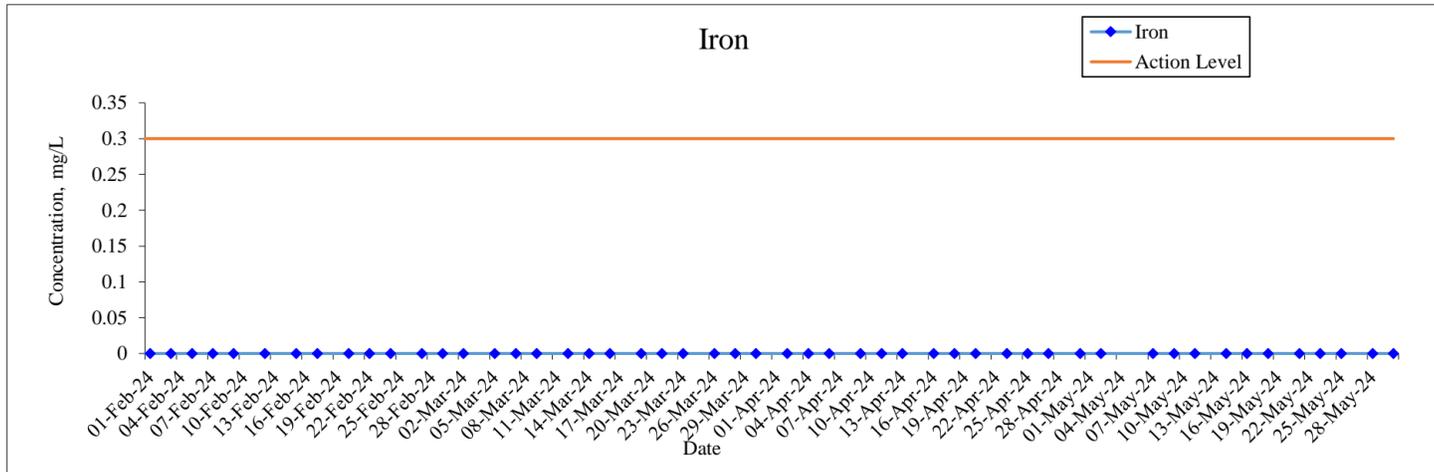
Monitoring Location: WSR4

Remark: The lowest detection limit of the Iron is 0.1mg/L. All result of iron monitoring are lower than the detection limit.

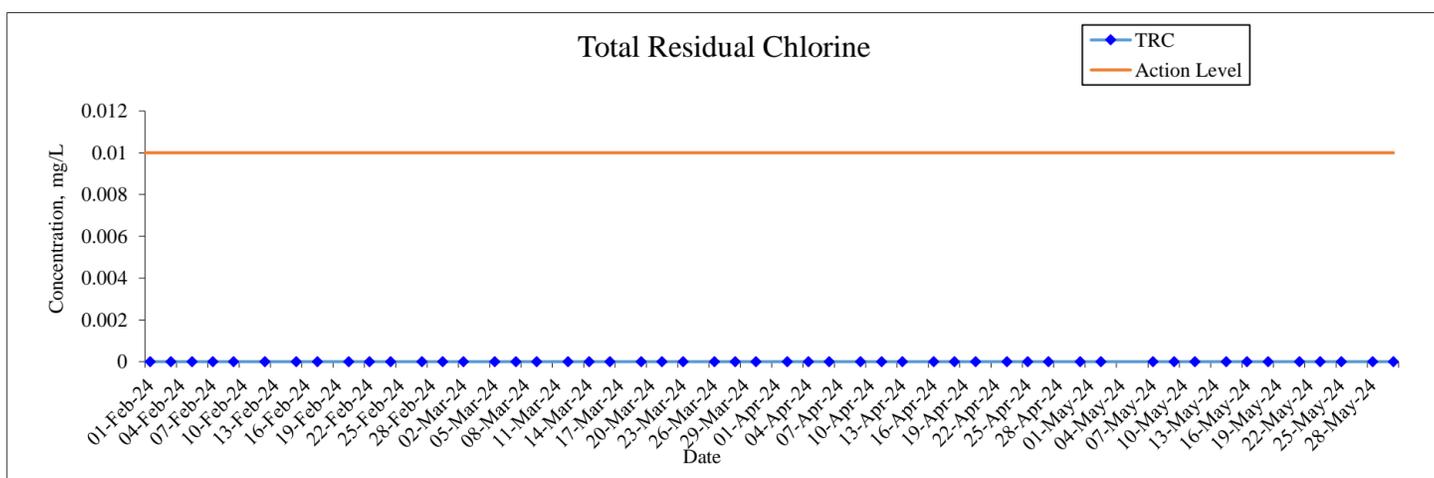
Remark: The lowest detection limit of the Total Residual Chlorine is 0.01mg/L. All result of Total Residual Chlorine monitoring are lower than the detection limit.

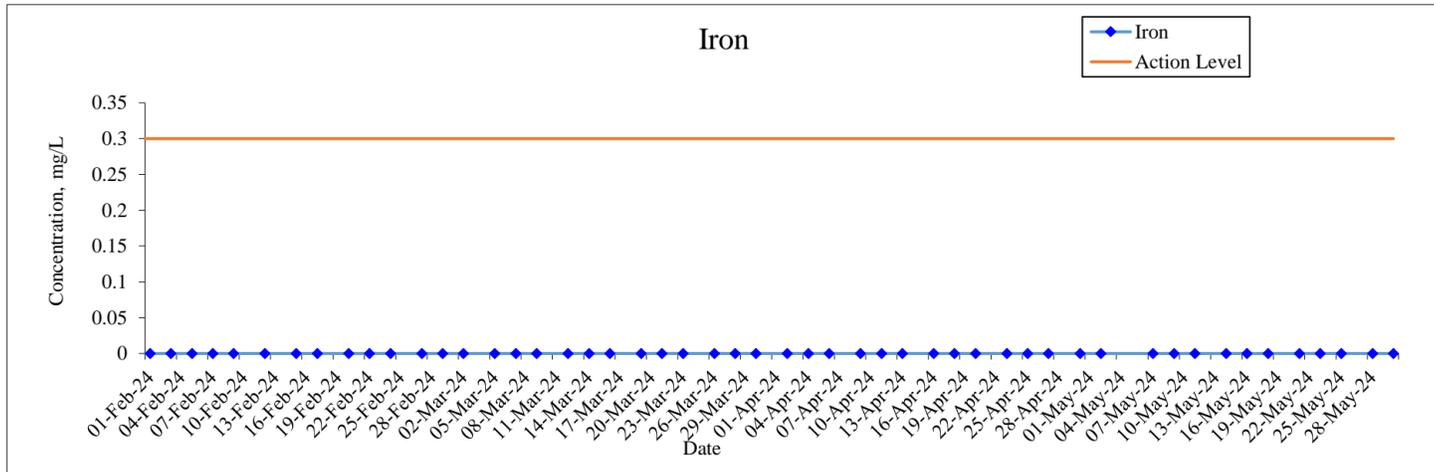
Monitoring Location: WSR16

Remark: The lowest detection limit of the Iron is 0.1mg/L. All result of iron monitoring are lower than the detection limit.

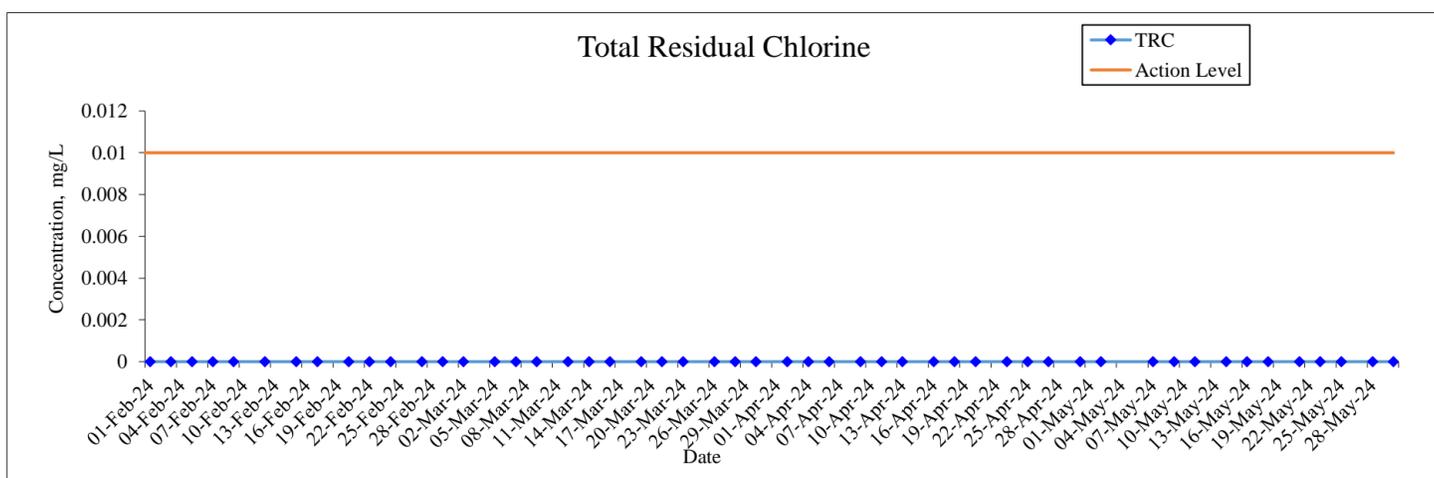
Remark: The lowest detection limit of the Total Residual Chlorine is 0.01mg/L. All result of Total Residual Chlorine monitoring are lower than the detection limit.

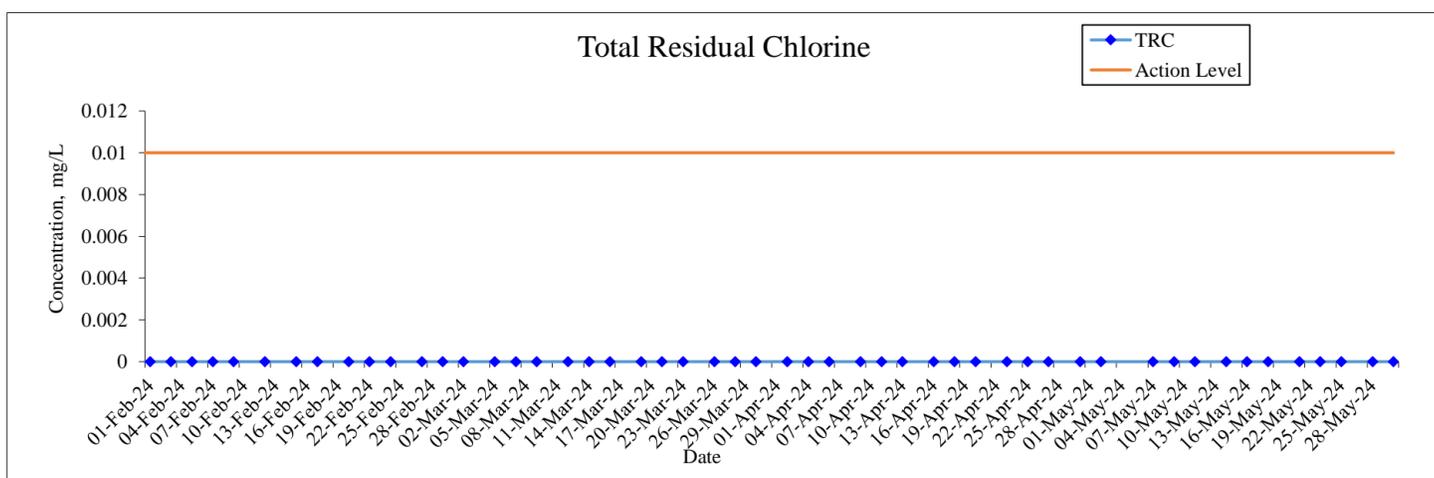
Remark: The lowest detection limit of the Total Residual Chlorine is 0.01mg/L. All result of Total Residual Chlorine monitoring are lower than the detection limit.

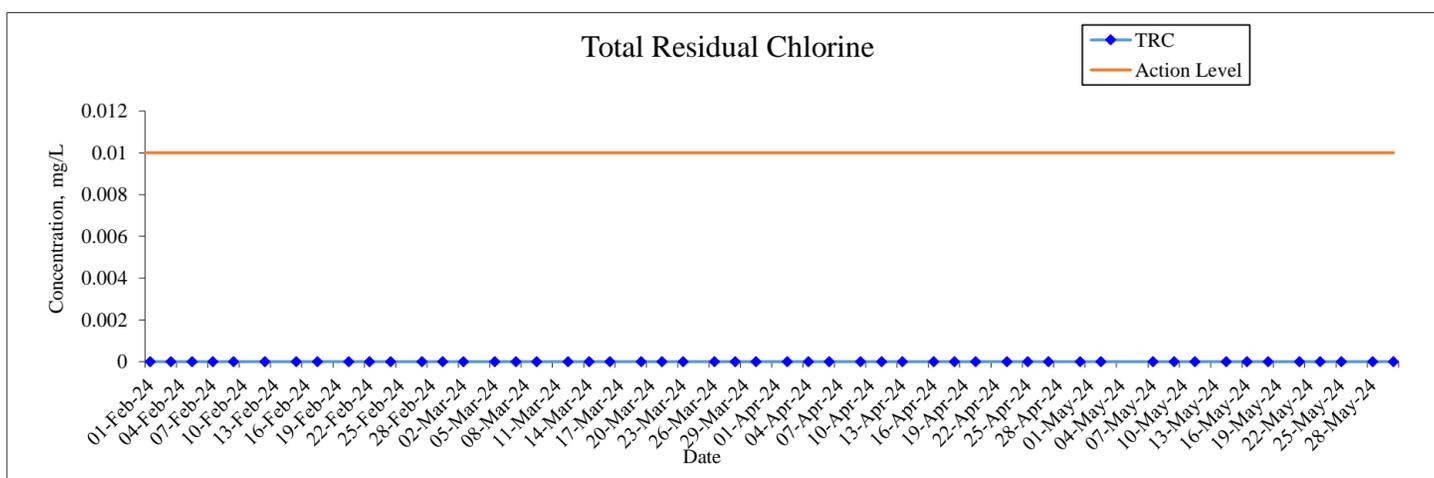
Remark: The lowest detection limit of the Total Residual Chlorine is 0.01mg/L. All result of Total Residual Chlorine monitoring are lower than the detection limit.

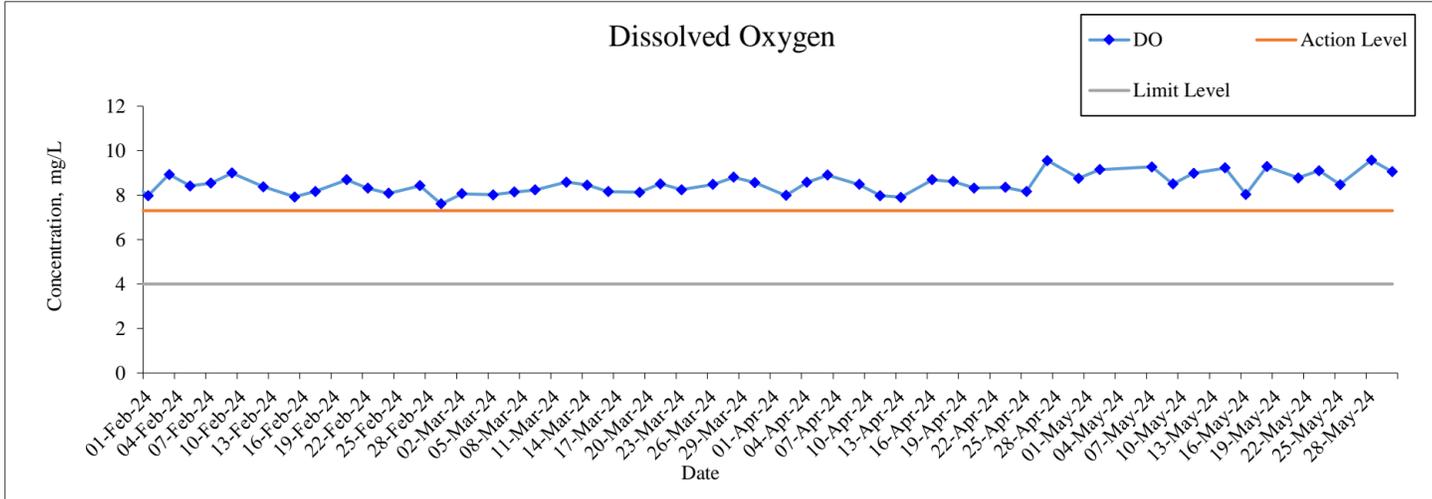
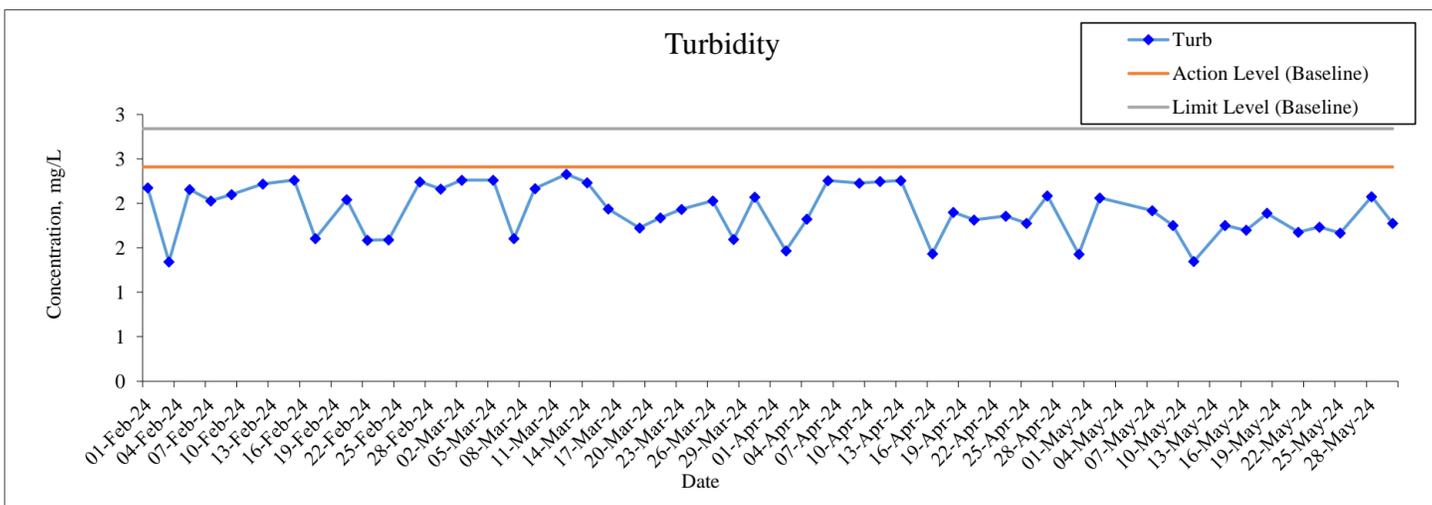
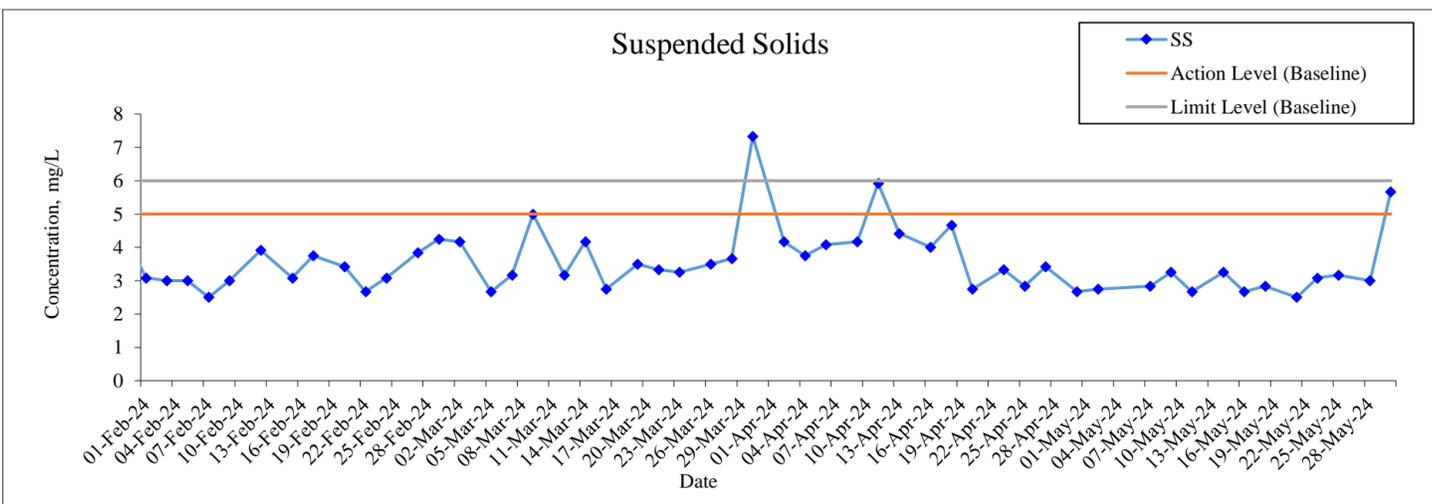
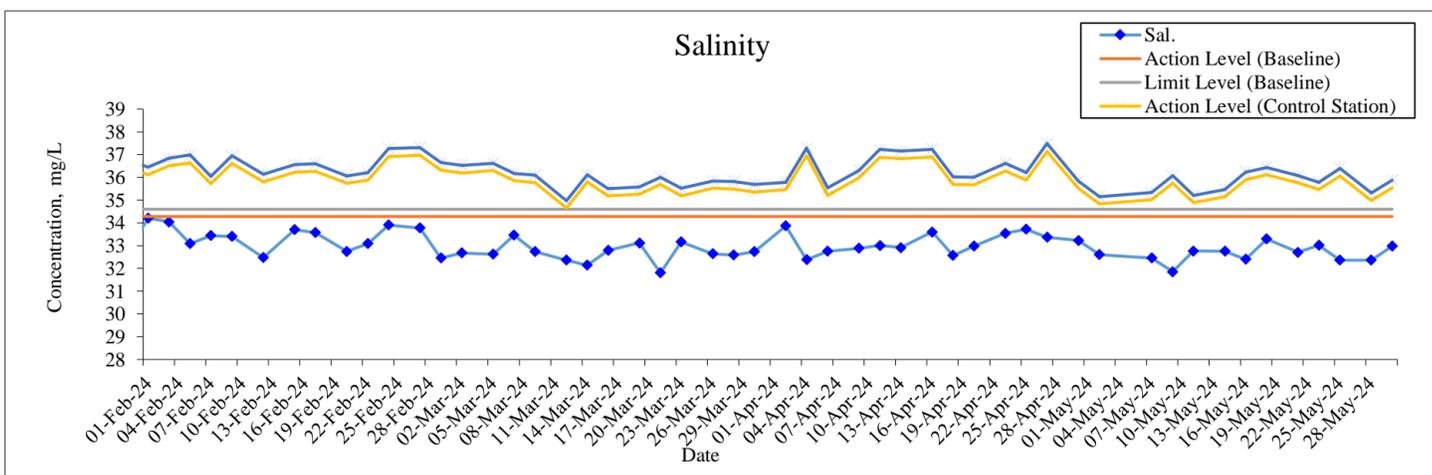
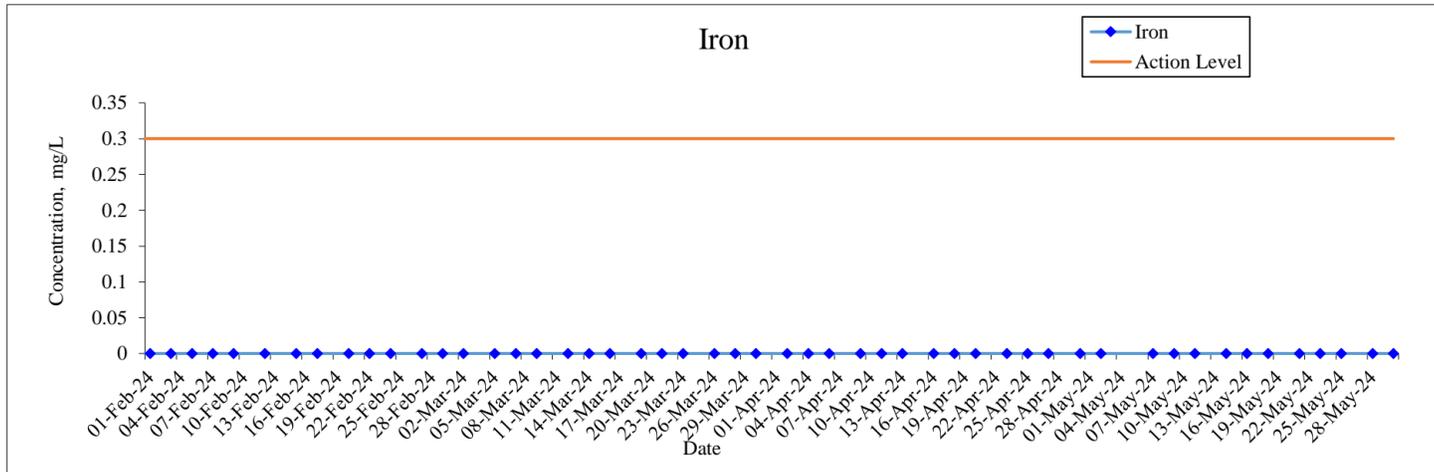
Monitoring Location: WSR37

Remark: The lowest detection limit of the Iron is 0.1mg/L. All result of iron monitoring are lower than the detection limit.

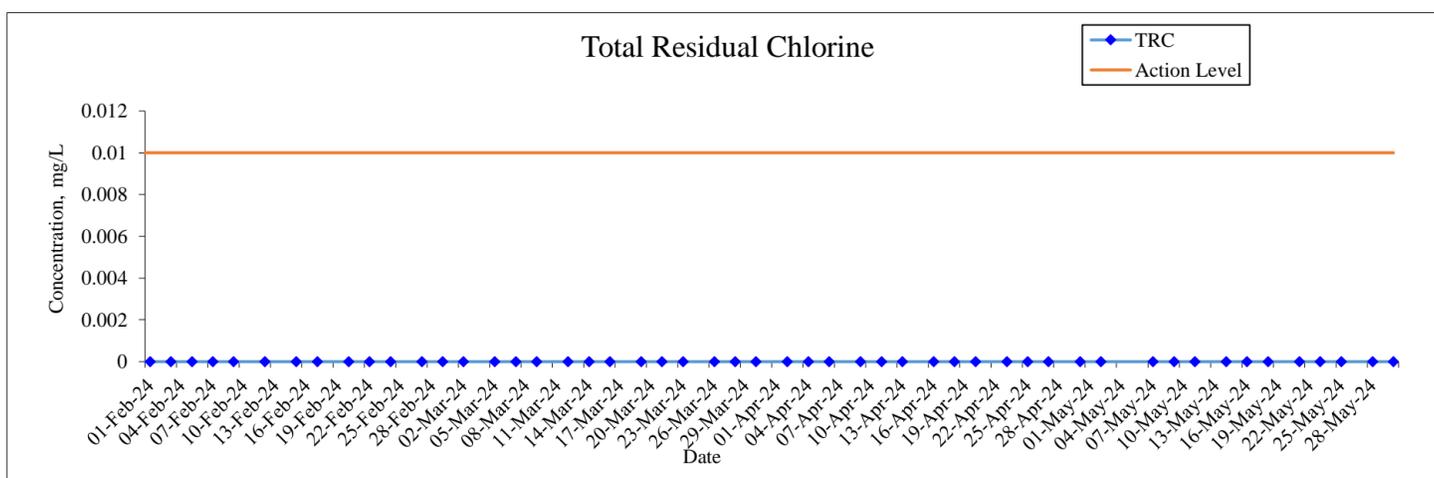
Remark: The lowest detection limit of the Total Residual Chlorine is 0.01mg/L. All result of Total Residual Chlorine monitoring are lower than the detection limit.
