Contract No. 13/WSD/17

**Design, Build and Operate First Stage of Tseung Kwan O
Desalination Plant**

**Quarterly EM&A Report No.17
(Period from 1 March 2024 to 31 May 2024)**

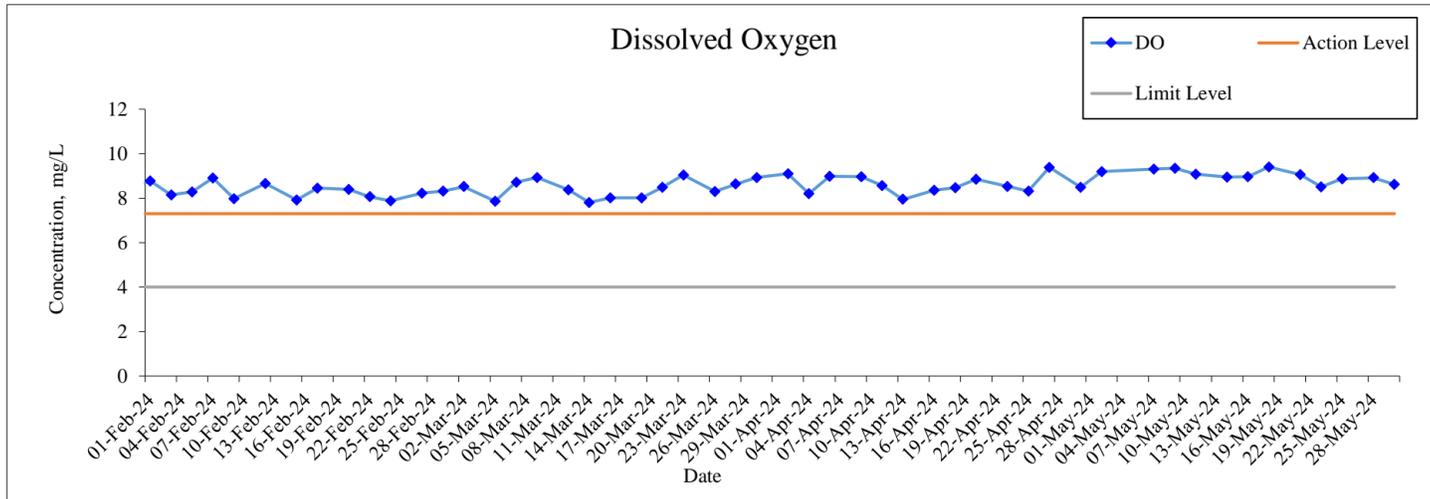
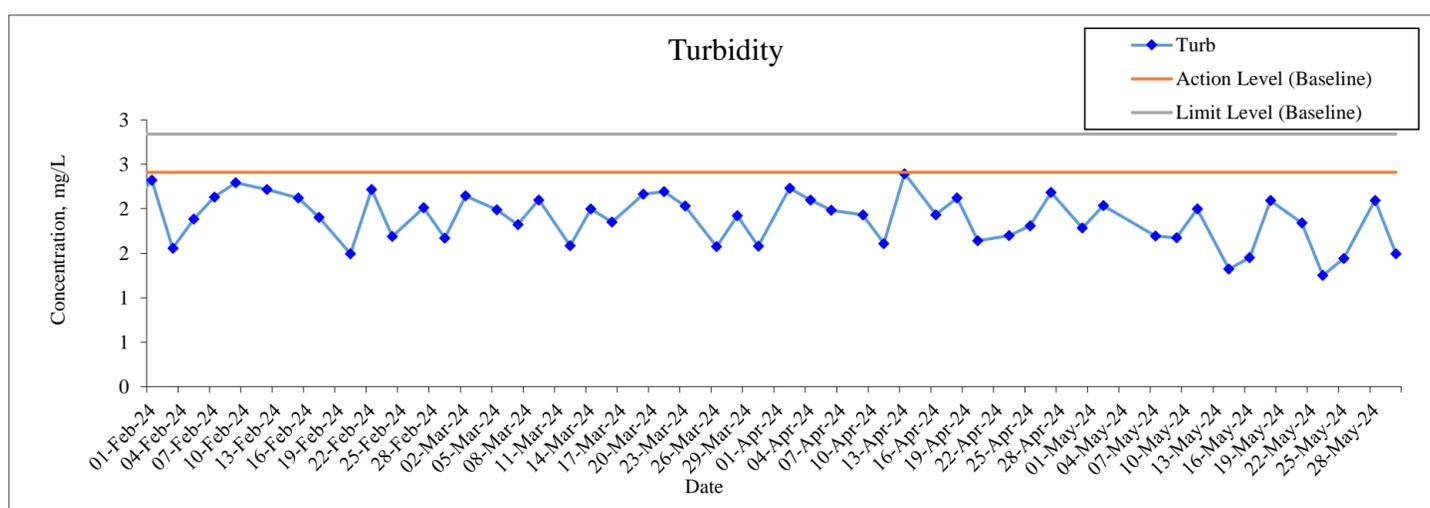
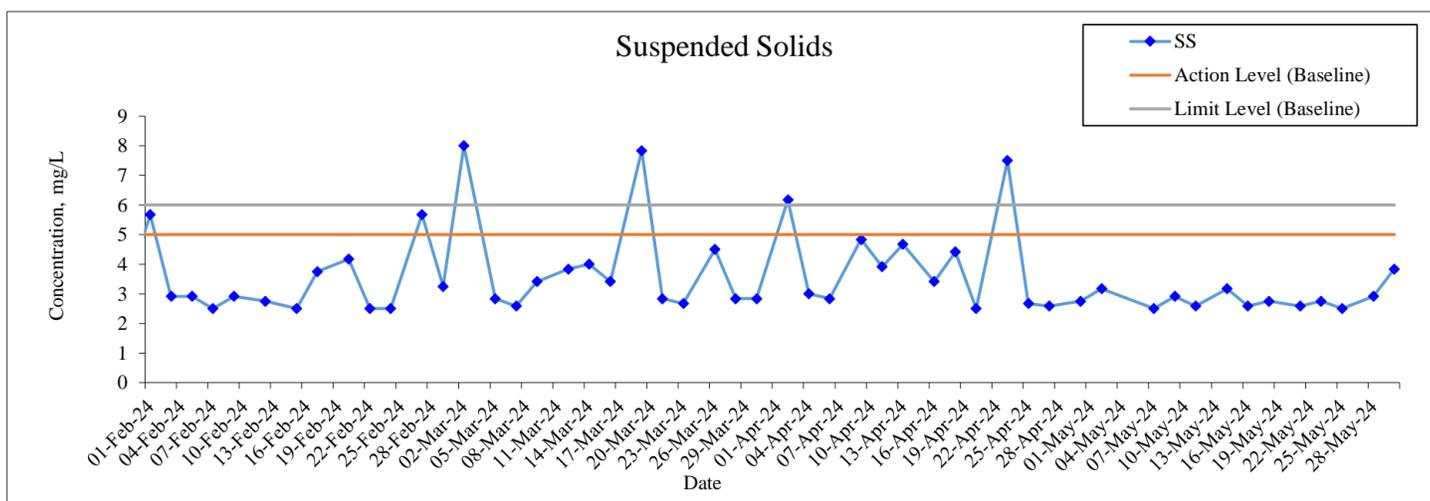
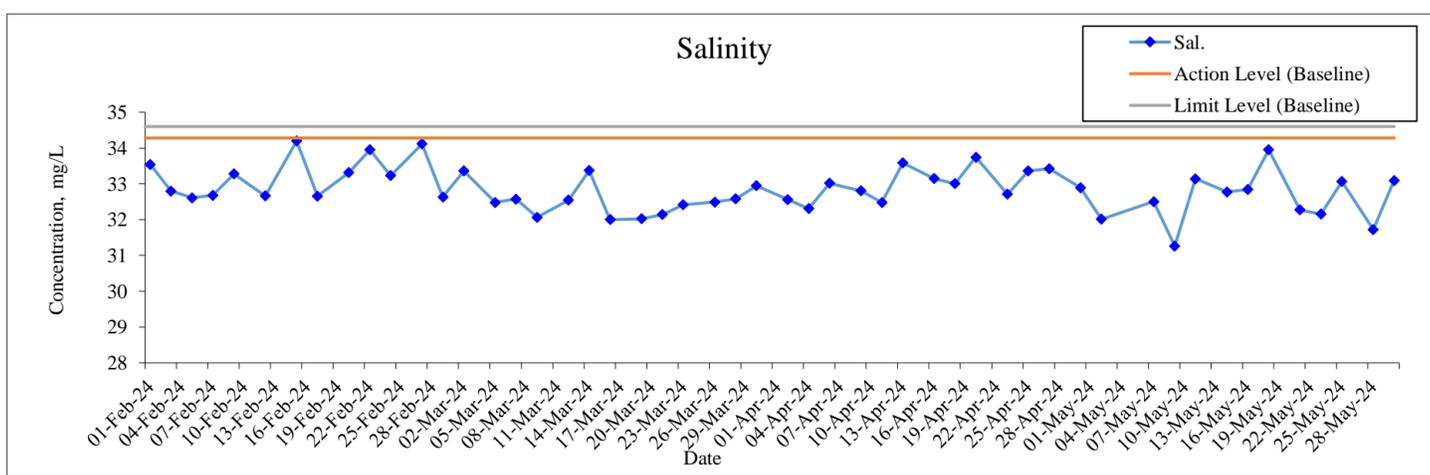
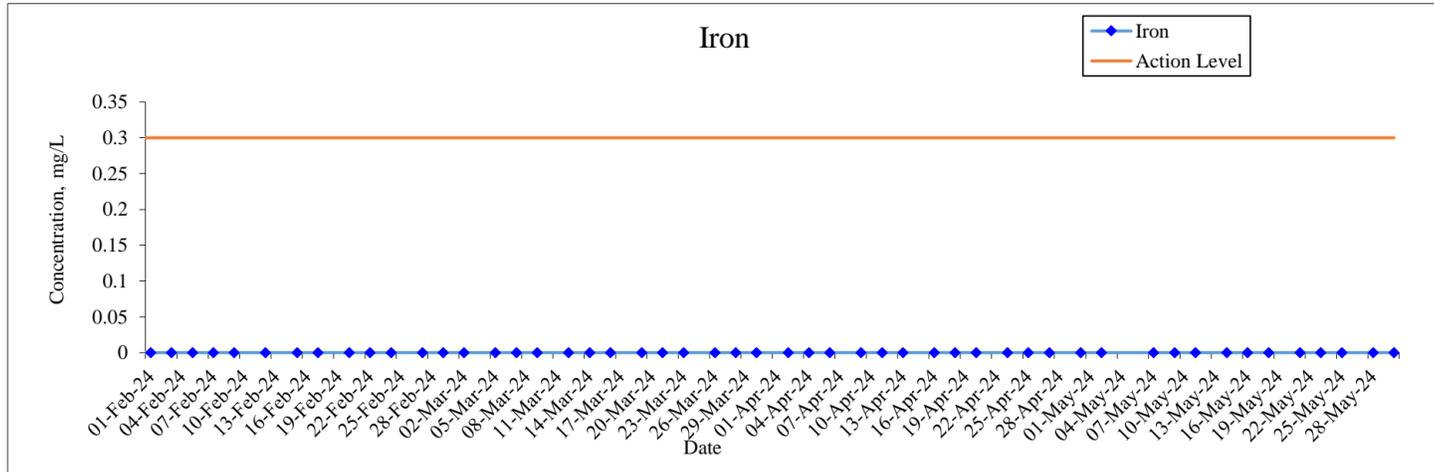
Monitoring Location: NF1

Remark: The lowest detection limit of the Iron is 0.1mg/L. All result of iron monitoring are lower than the detection limit.

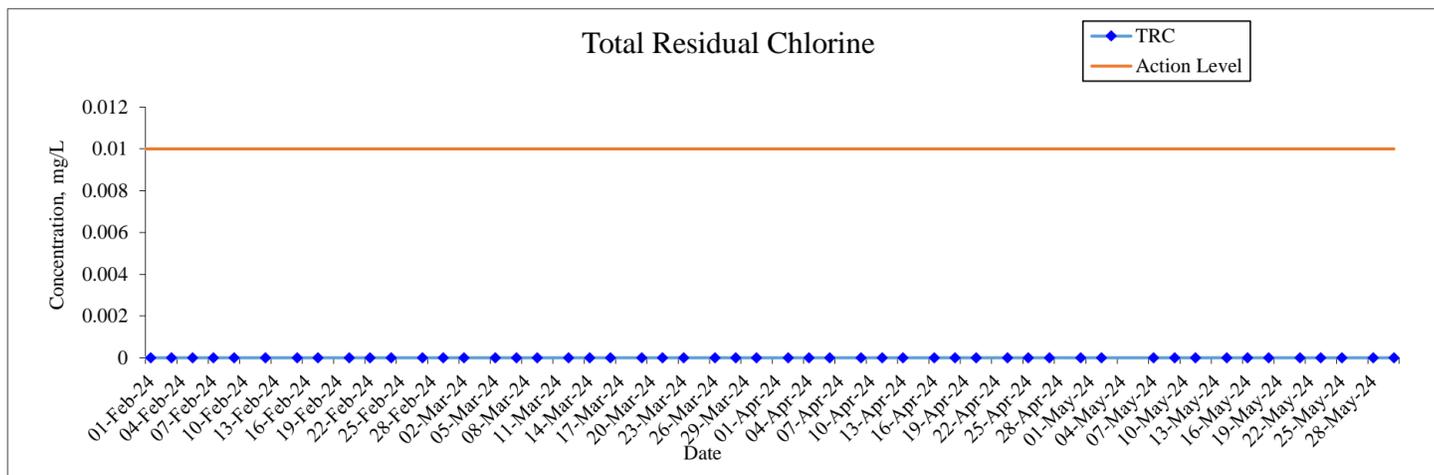
Remark: The lowest detection limit of the Total Residual Chlorine is 0.01mg/L. All result of Total Residual Chlorine monitoring are lower than the detection limit.

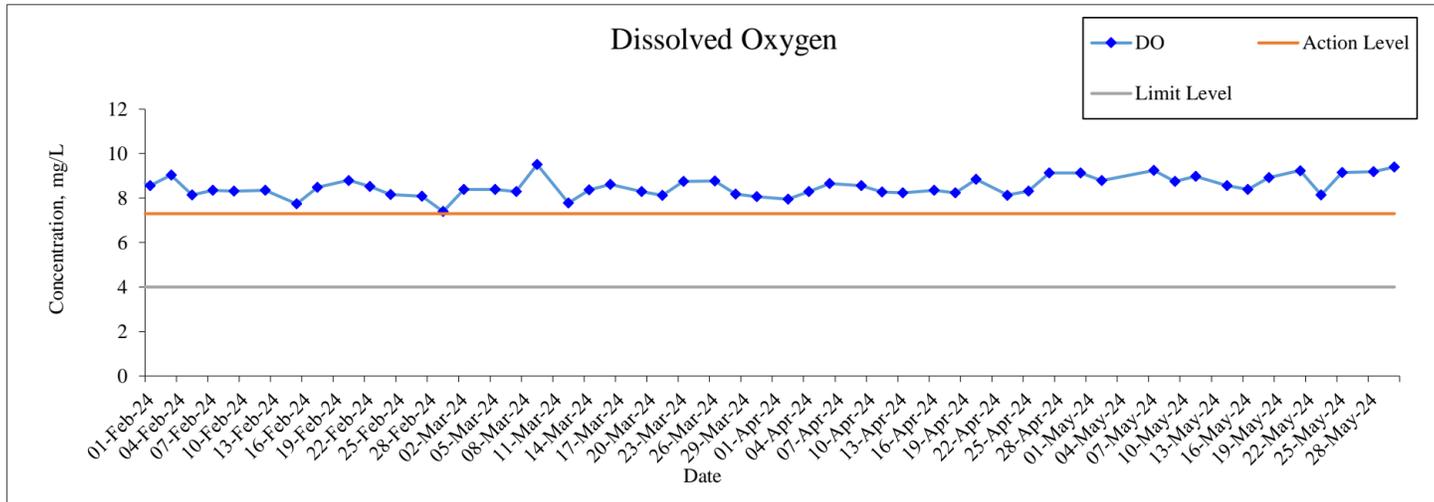
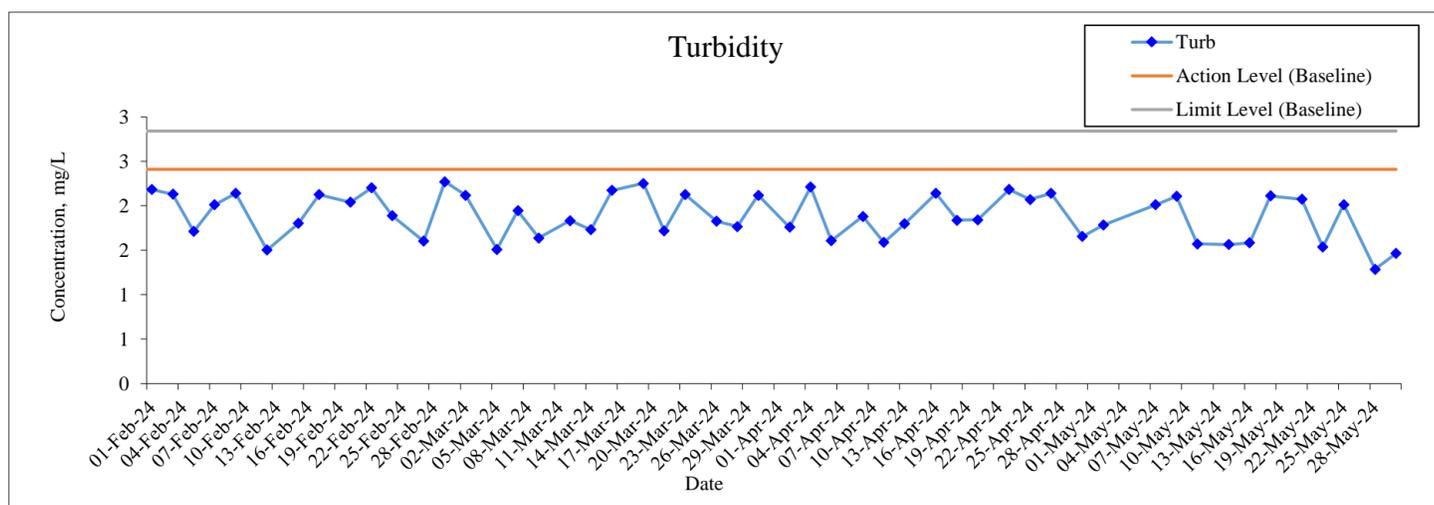
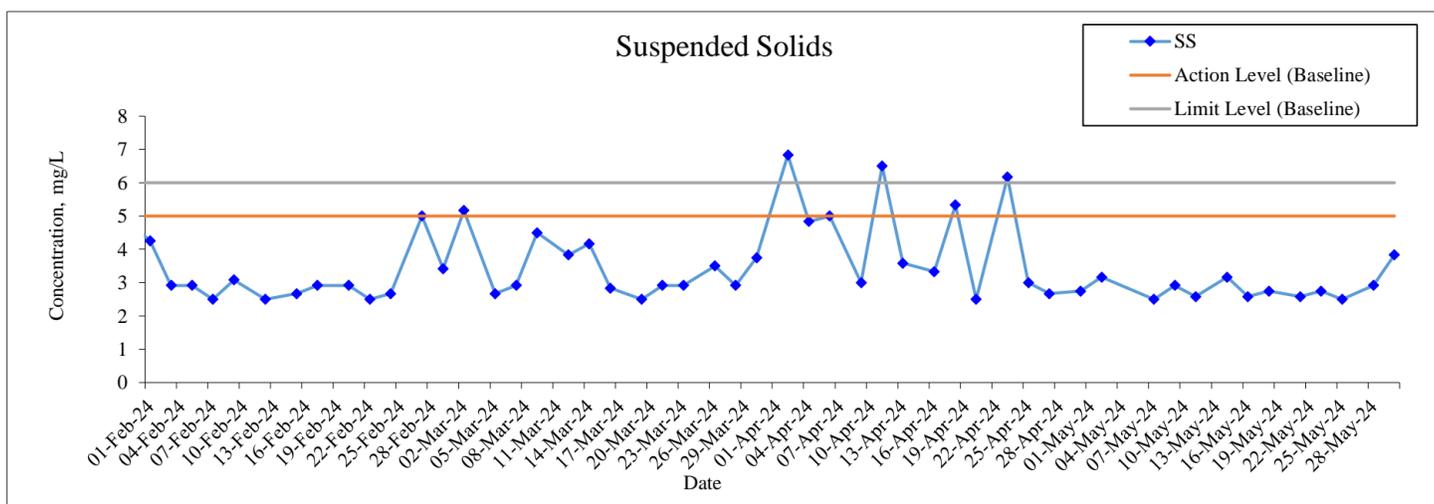
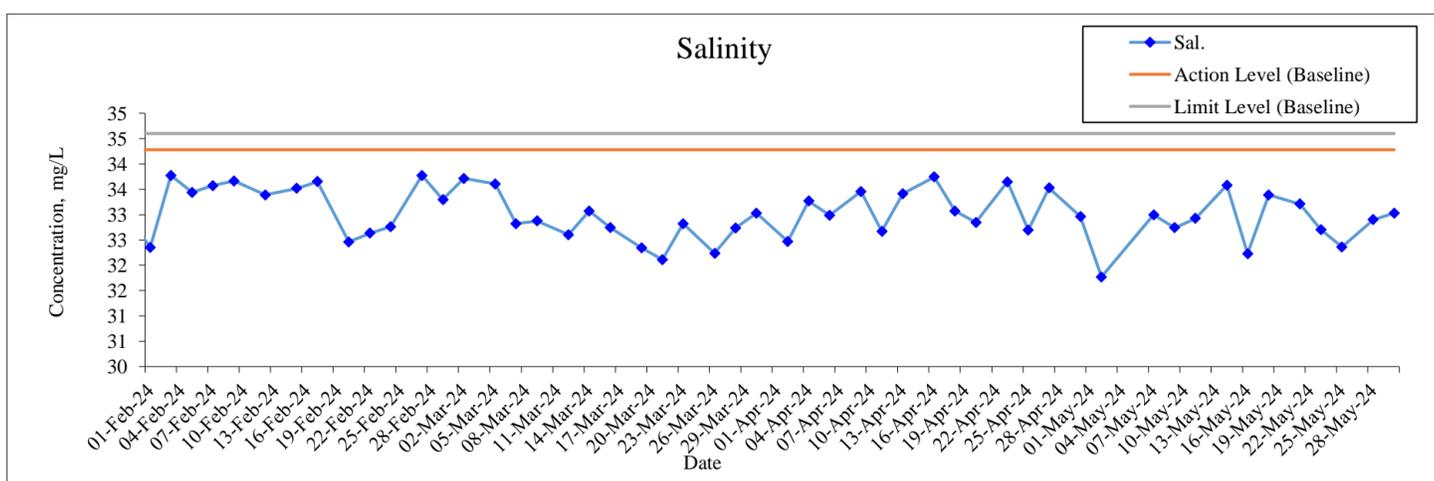
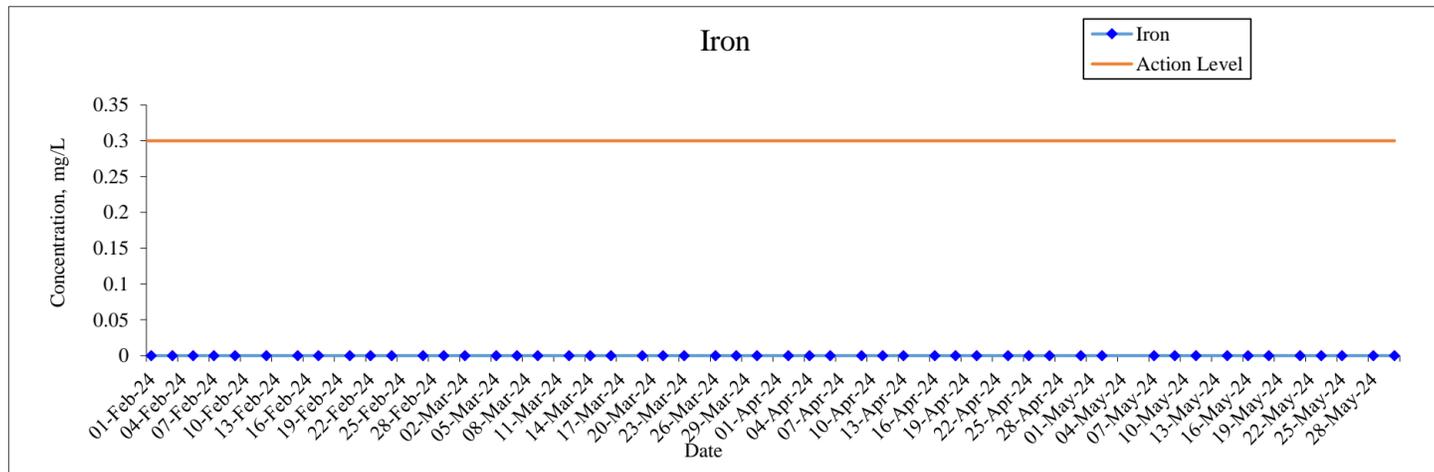
Monitoring Location: NF2

Remark: The lowest detection limit of the Iron is 0.1mg/L. All result of iron monitoring are lower than the detection limit.

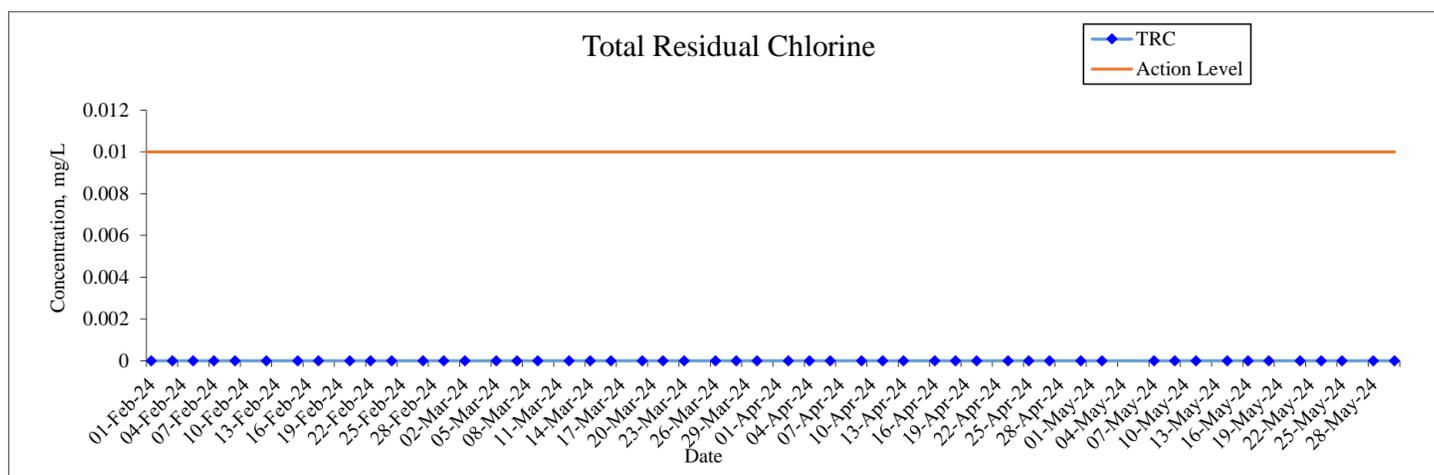
Remark: The lowest detection limit of the Total Residual Chlorine is 0.01mg/L. All result of Total Residual Chlorine monitoring are lower than the detection limit.

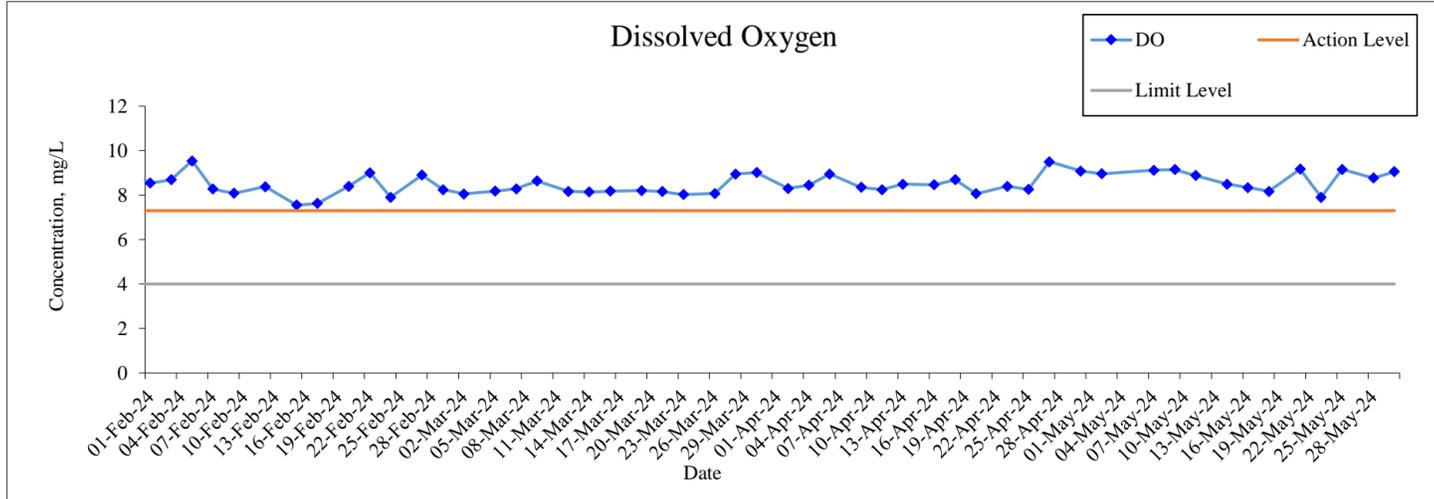
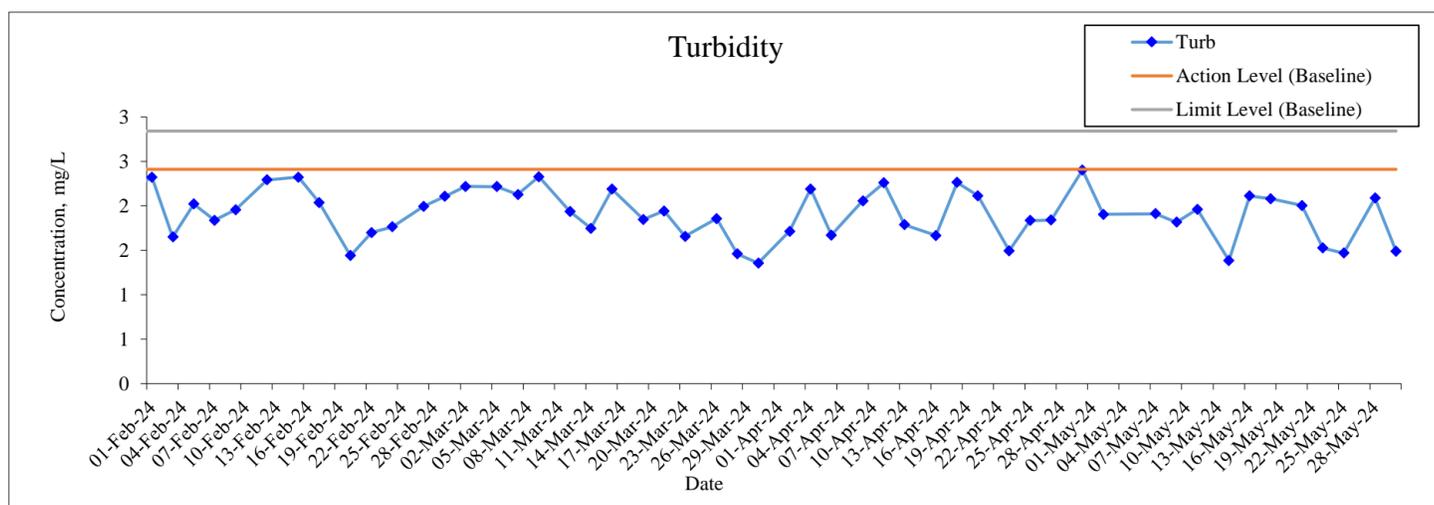
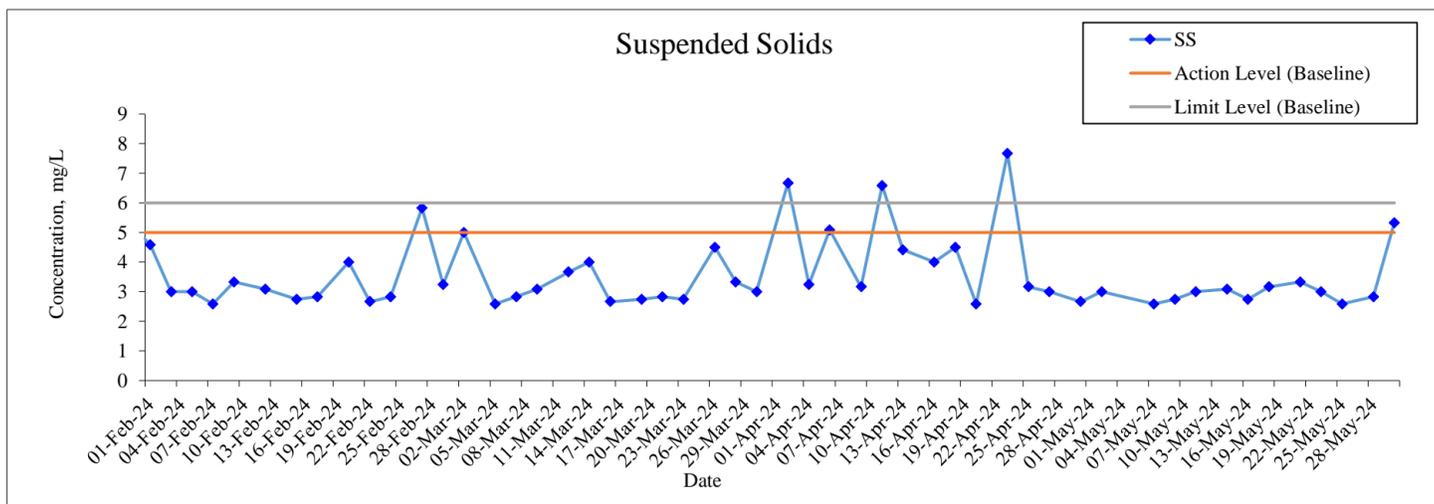
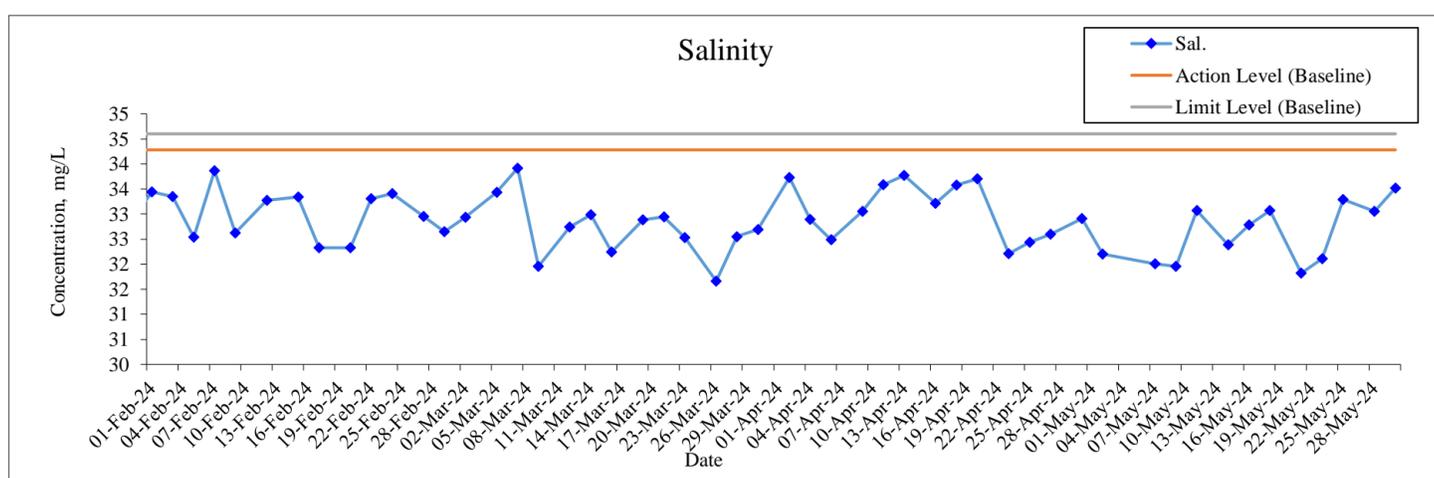
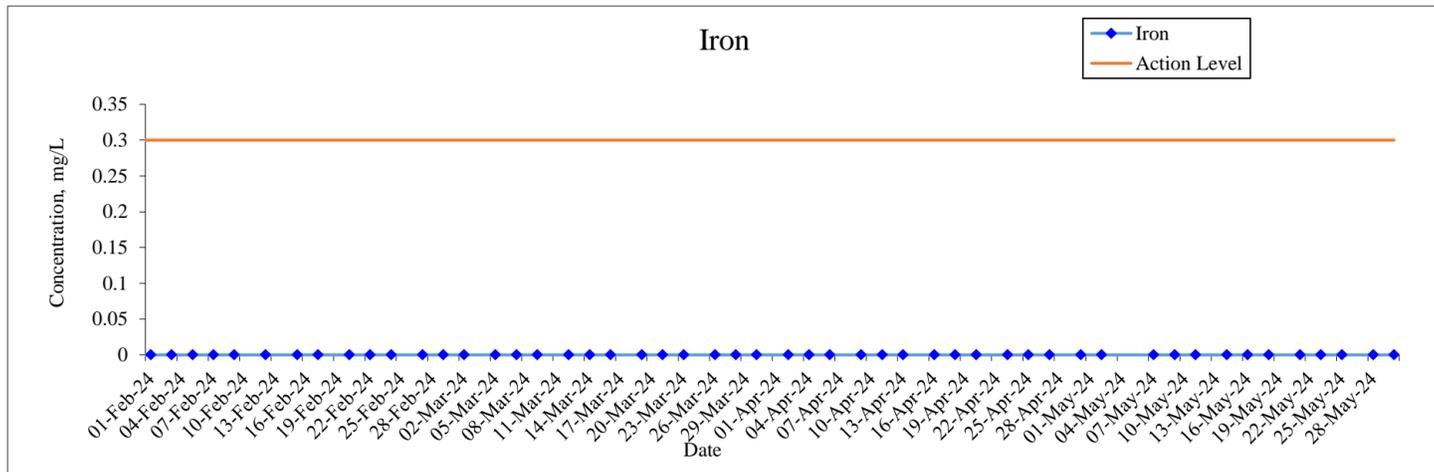
Monitoring Location: NF3

Remark: The lowest detection limit of the Iron is 0.1mg/L. All result of iron monitoring are lower than the detection limit.

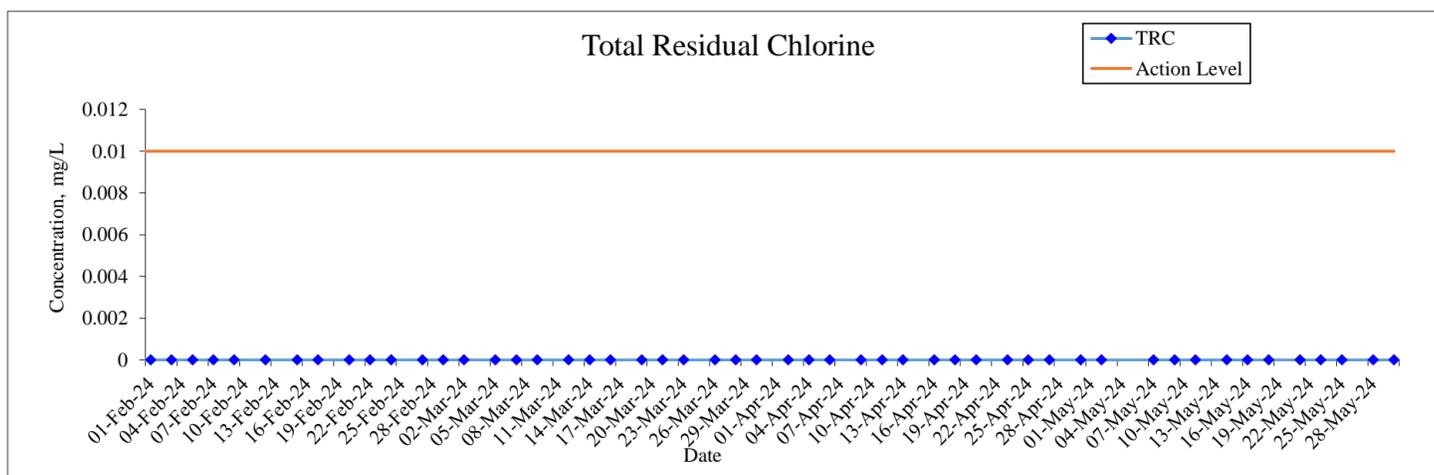
Remark: The lowest detection limit of the Total Residual Chlorine is 0.01mg/L. All result of Total Residual Chlorine monitoring are lower than the detection limit.
