Contract No. 13/WSD/17

**Design, Build and Operate First Stage of Tseung Kwan O
Desalination Plant**

**Annual EM&A Review Report No.3
(Period from May 2022 to April 2023)**

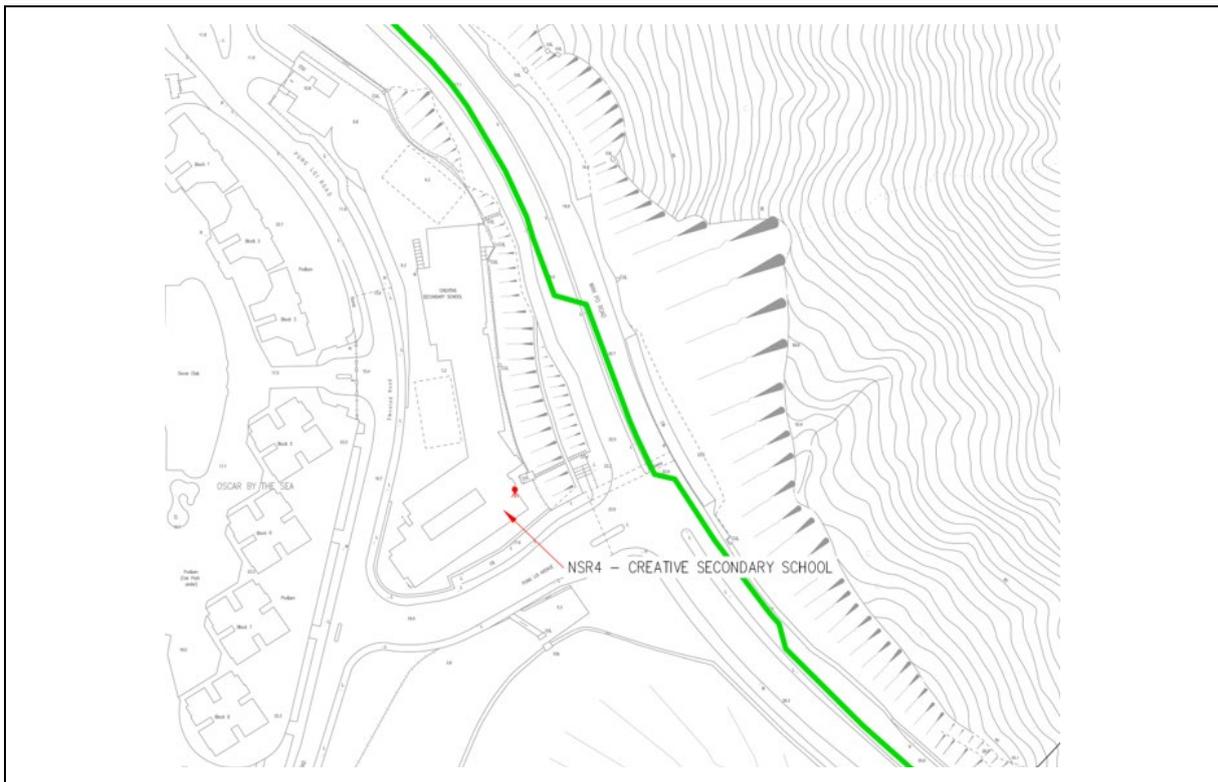
Figure 2.1 NSR4 Creative Secondary School

NSR ID	Noise Sensitive Receivers	Monitoring Location	Position
NSR 4	Creative Secondary School	Roof Floor	1 m from facade
NSR 24	PLK Laws Foundation College	Pedestrian Road on Ground Floor	Free field
NSR 31	School of Continuing and Professional Studies - CUHK	Roof Floor	1 m from facade

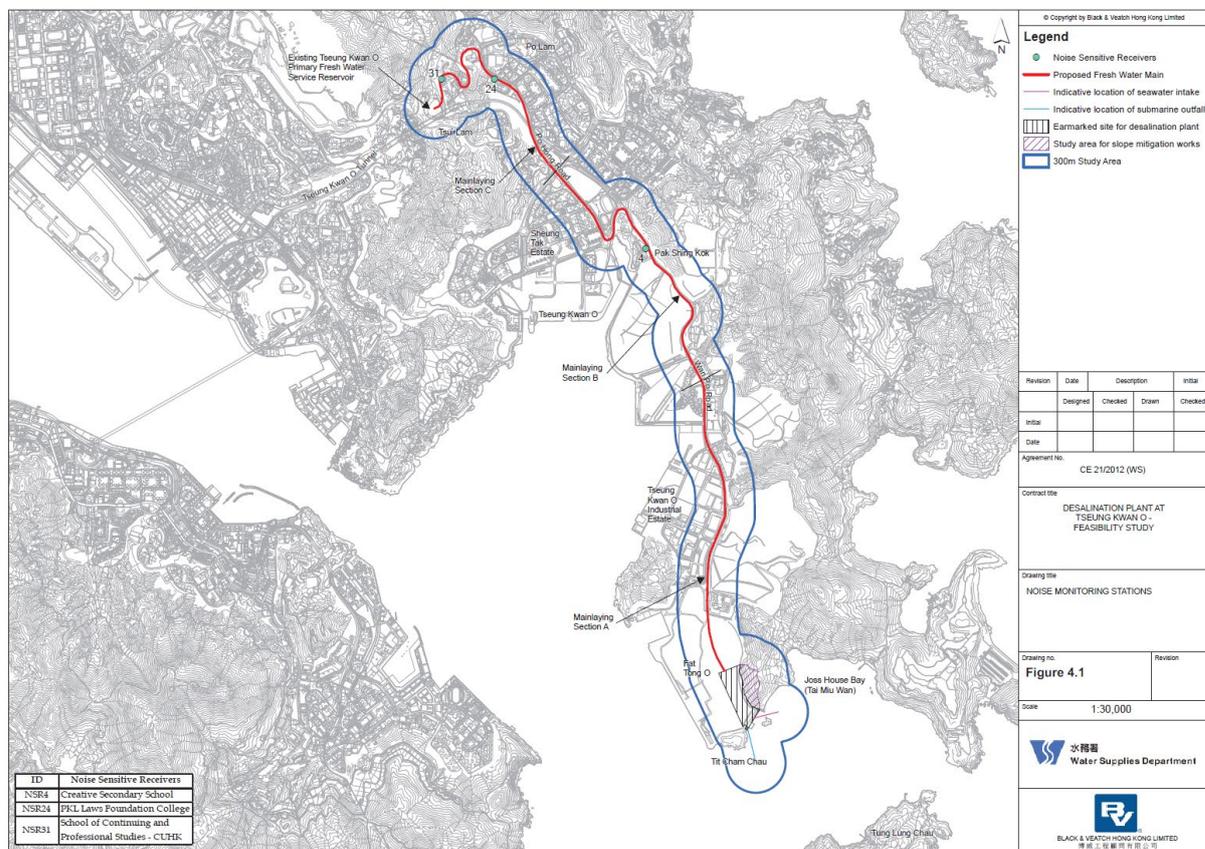
Figure 2.4 Site Layout Plan with Noise Sensitive Receivers and Desalination Plant

To ensure no adverse noise impact, noise monitoring is recommended to be carried out within 300m radius from the nearby noise sensitive receivers (NSRs), during construction phase. The NSRs selected as monitoring station are (i) NSR4 – Creative Secondary School, (ii) NSR24 – PLK Laws Foundation College, and (iii) NSR31 – School of Continuing and Professional Studies – CUHK respectively.

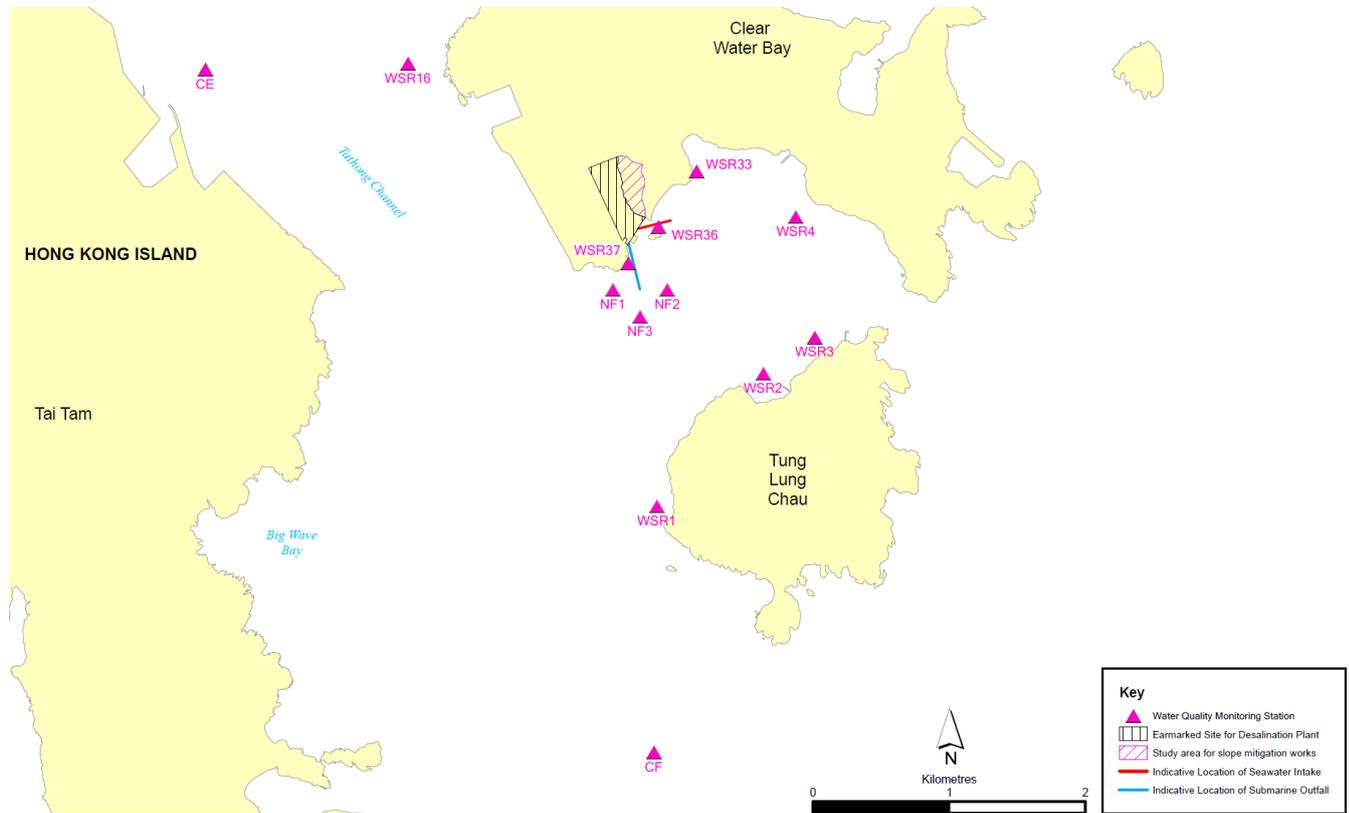
Figure 3.1 Impact water quality monitoring locations under EM&A Manual

WSR1 to WSR37 were identified in accordance with Annex 14 of the EIAO-TM as well as Clause 3.4.4.2 of the Environmental Impact Assessment Study Brief for Desalination Plant at Tseung Kwan O (No. ESB-266/2013). WSR1 to WSR3 are sited near the Tung Lung Chau Fish Culture Zone; WSR16 and WSR36 are sited near the coral assemblages along the

coastlines of Fat Tong Chau and Kwun Tsai respectively; WSR 4 and WSR33 are sited near the Coastal Protection Area and coral assemblages in waters of Tai Miu Wan; WSR37 is sited near the fisheries resource including spawning and nursery grounds at the coastal water of Tit Cham Chau.

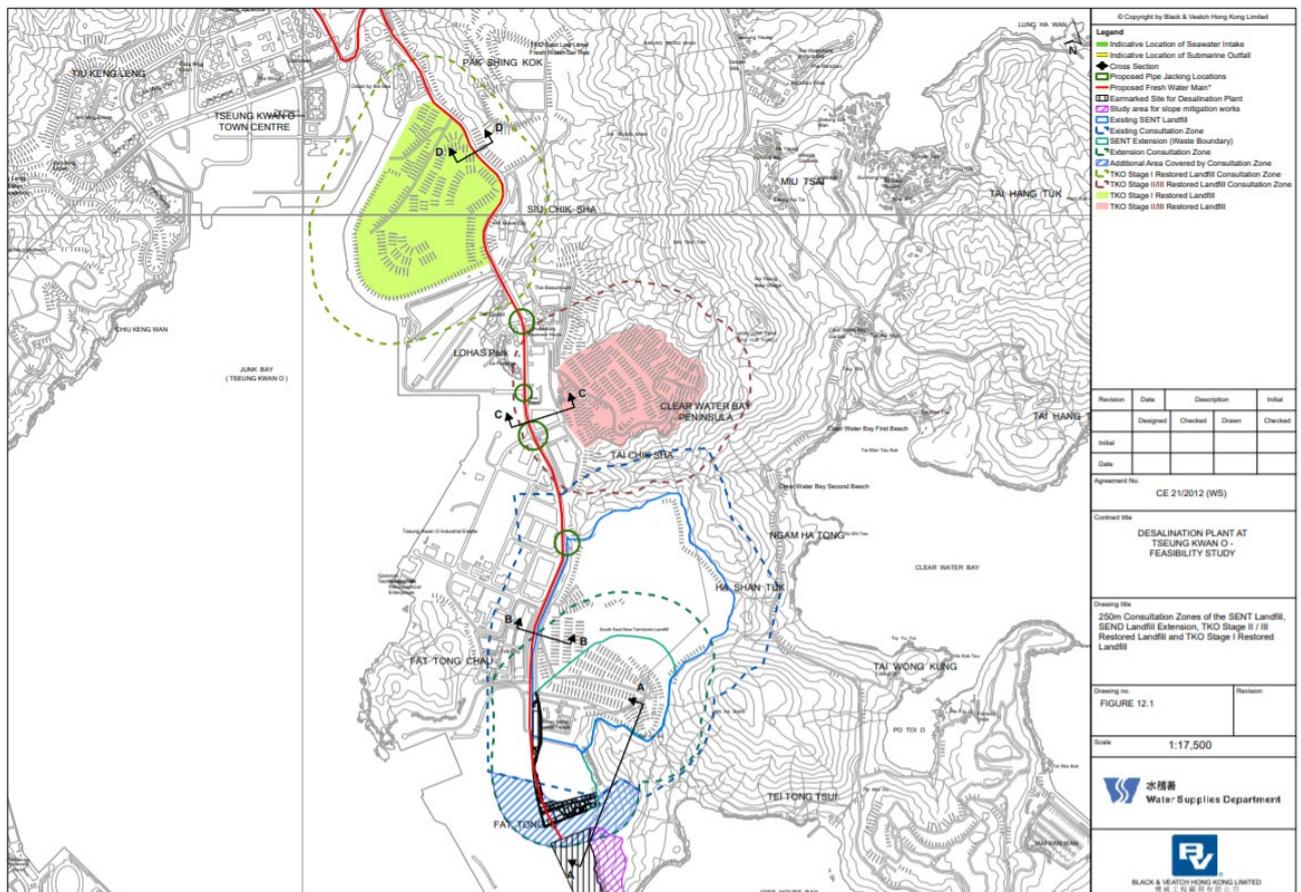
Figure 5.1 Overview of the SENT Extension Consultation Zone and the Contract Site Area

In according with Section 11 of the EM&A Manual, monitoring of landfill gas is required for construction works within the 250m Consultation Zone. Part of the desalination plant and the indicative area of natural slope mitigation works fall within the SENT Landfill Extension Consultation Zone; and part of the 1,200 mm diameter freshwater mains along Wan Po Road falls within the SENT Landfill and SENT Landfill Extension Consultation Zones, TKO Stage II/III Restored Landfill and TKO Stage I Restored Landfill Consultation Zones.

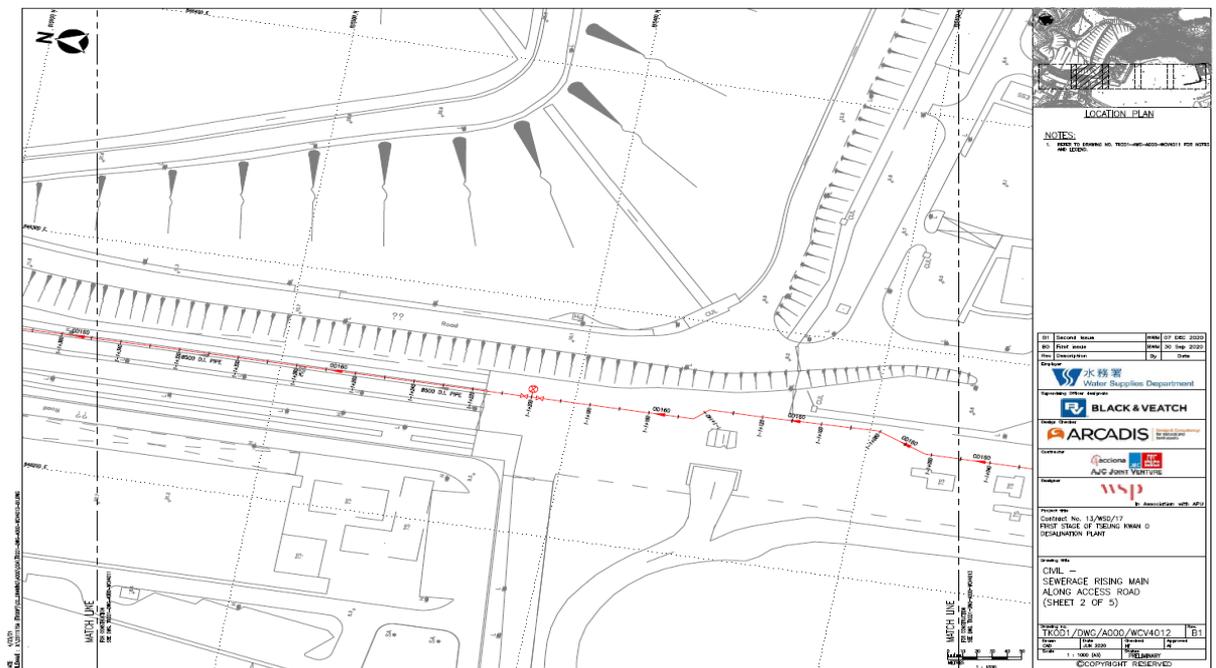
Figure 5.2 Location Map for Landfill Gas Monitoring at Wan Po Road

Since part of the desalination plant (Wan Po Road and MIC compound/Basketball Court) and the indicative area of natural slope mitigation works fall within the SENT Landfill Extension Consultation Zone in this contract (Figure 5.1), landfill gas monitoring would be required for Wan Po Road and MIC compound/Basketball Court (Figure 5.2) if excavations were conducted at more than 300mm deep. Although SENT Landfill Extension has commenced operation since November 2021, no excavation works were conducted at MIC compound/Basketball Court. Hence no landfill gas monitoring would be scheduled for MIC compound/Basketball Court at the current stage.

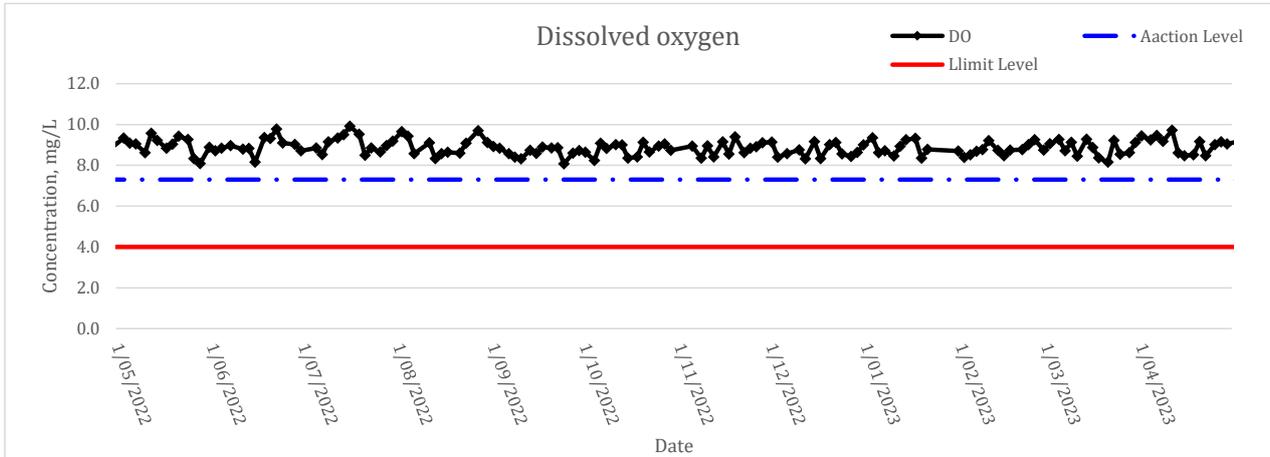
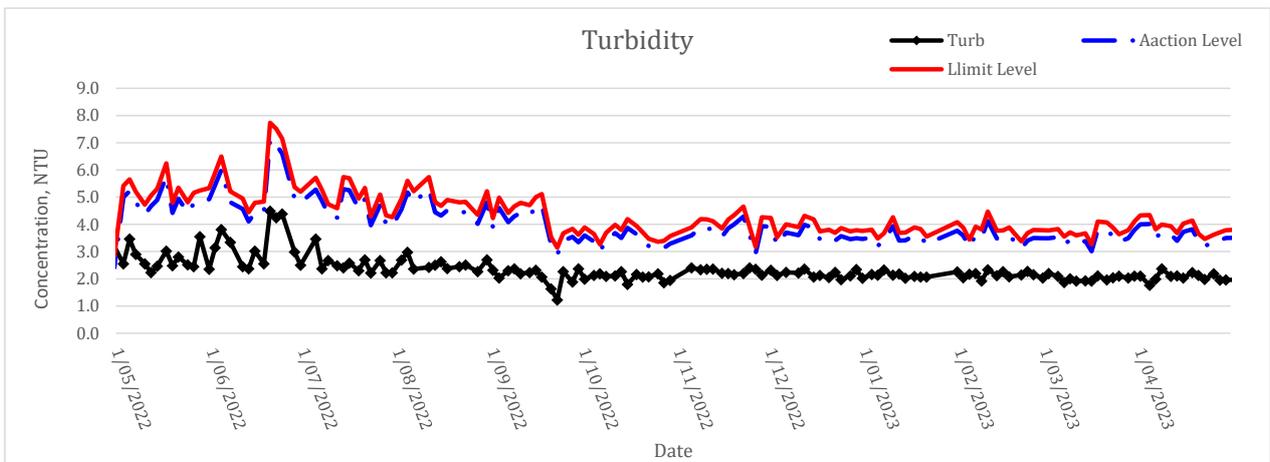
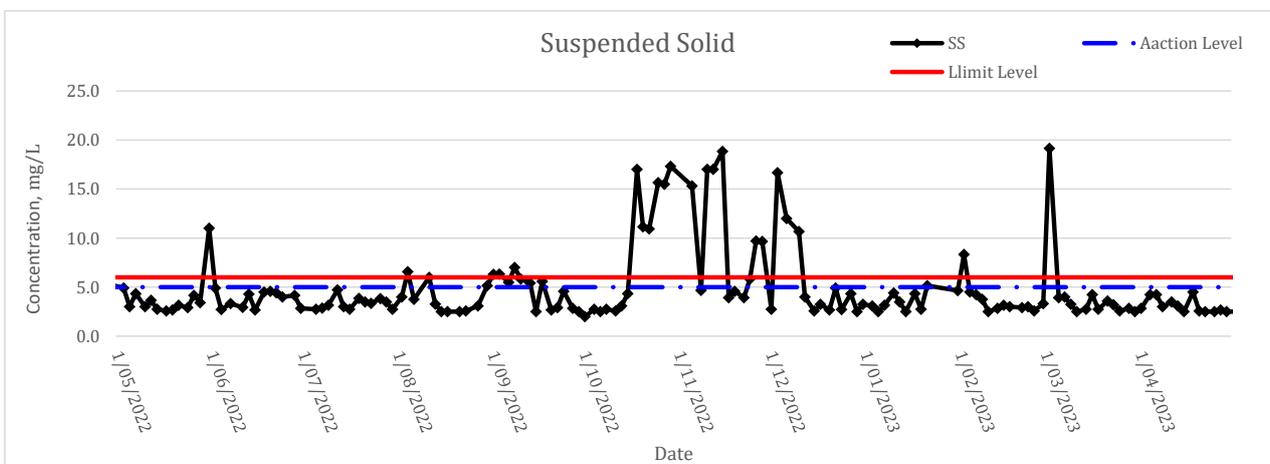
Monitoring Location : WSR 1

Middle-Flood Tide

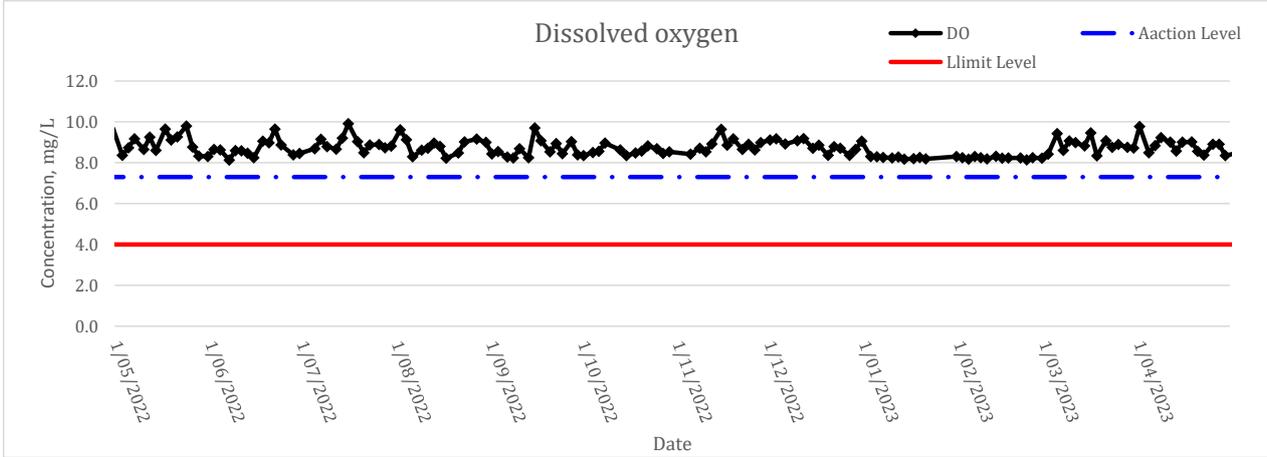
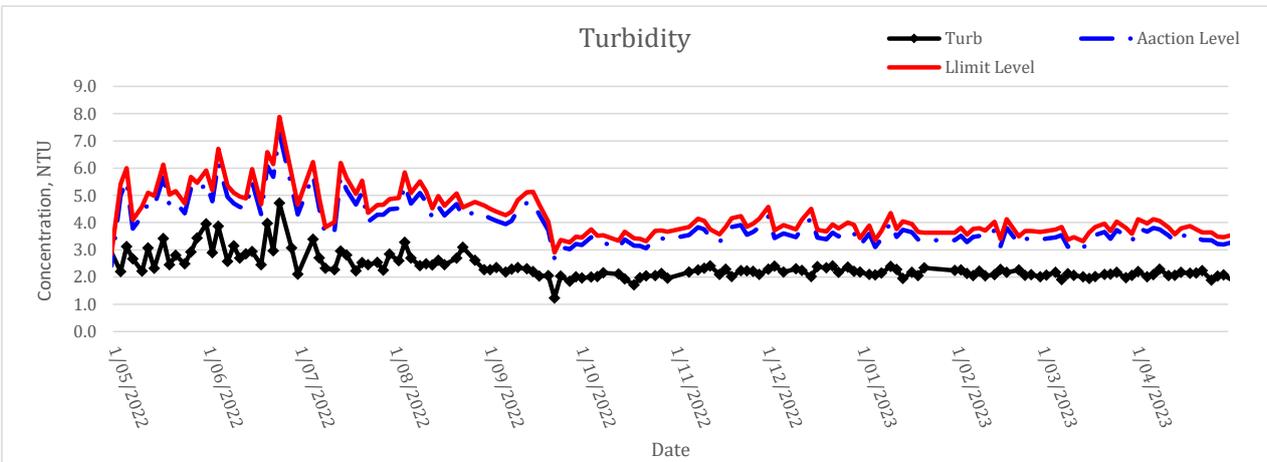
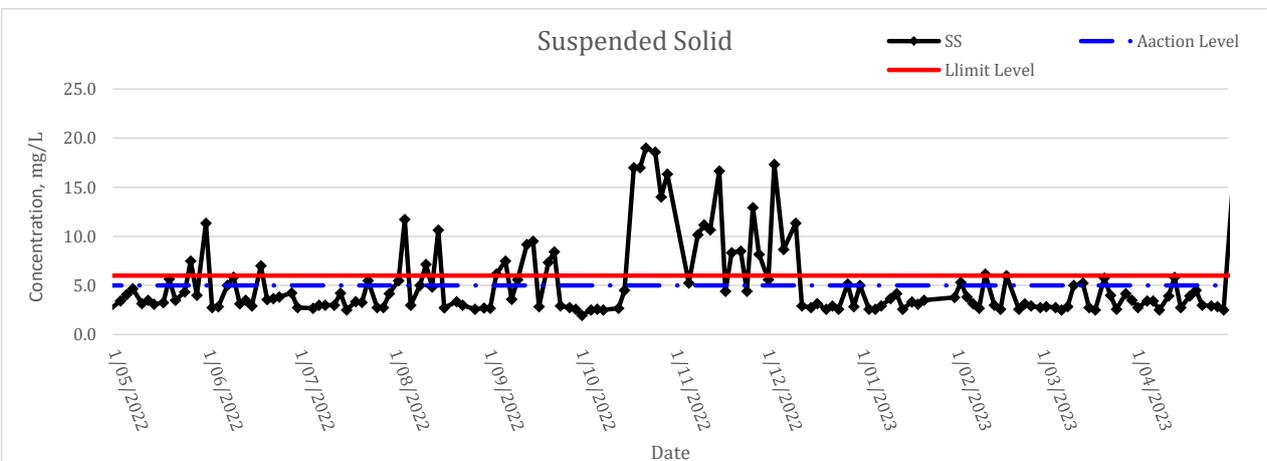
Monitoring Location : WSR 1

Middle-Ebb Tide
