Contract No. 13/WSD/17

Design, Build and Operate First Stage of Tseung Kwan O Desalination Plant

Quarterly EM&A Report No.12 (Period from 1 December 2022 to 28 February 2023)

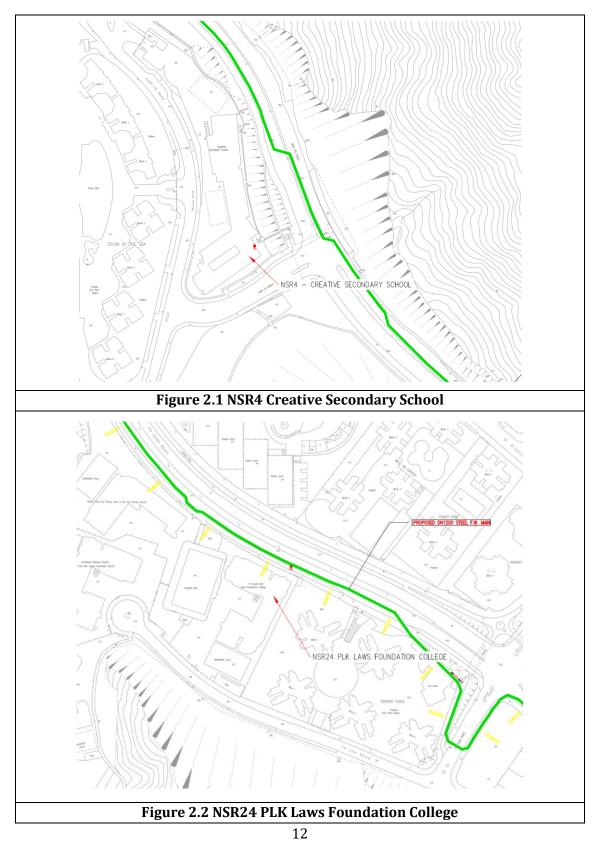
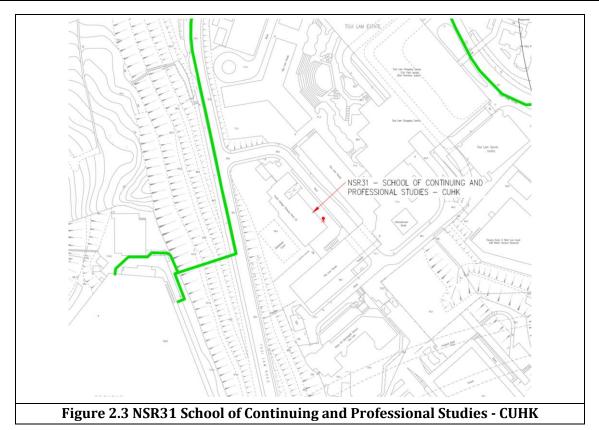
The monitoring locations should normally be made at a point 1m from the exterior of the NSRs building façade and be at a position 1.2m above the ground. A correction of +3dB(A) should be made to the free-field measurements. Three noise monitoring locations for impact monitoring at the nearby sensitive receivers are shown in **Figure 2.1-2.3**.

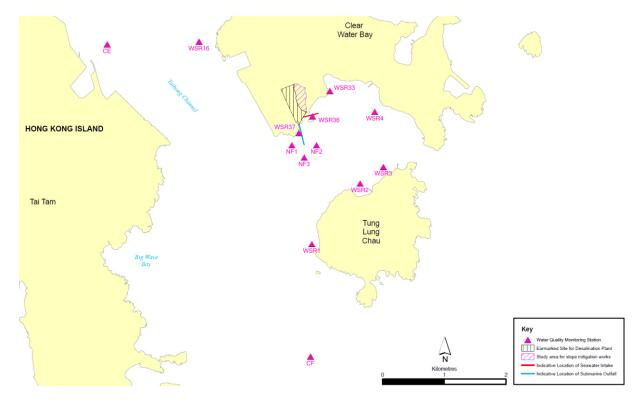
Figure 3.1 Impact Water Quality Monitoring Locations under EM&A Manual

Station	Easting	Northing	Description
CE	843550	815243	Upstream control station at ebb tide
CF	846843	810193	Upstream control station at flood tide
WSR1	846864	812014	Ecological sensitive receiver at Tung Lung Chau
WSR2	847645	812993	Fisheries sensitive receiver at Tung Lung Chau
WSR3	848023	813262	Ecological sensitive receiver at Tung Lung Chau
WSR4	847886	814154	Ecological sensitive receiver at Tai Miu Wan
WSR16	845039	815287	Ecological sensitive receiver at Fat Tong Chau
WSR33	847159	814488	Ecological sensitive receiver at Tai Miu Wan
WSR36	846878	814081	Ecological sensitive receiver at Kwun Tsai
WSR37	846655	813810	Ecological sensitive receiver at Tit Cham Chau
NF1	846542	813614	Edge of mixing zone, ~ 200m west of outfall diffuser
NF2	846942	813614	Edge of mixing zone, ~ 200m east of outfall diffuser
NF3	846742	813414	Edge of mixing zone, \sim 200m south of outfall diffuser

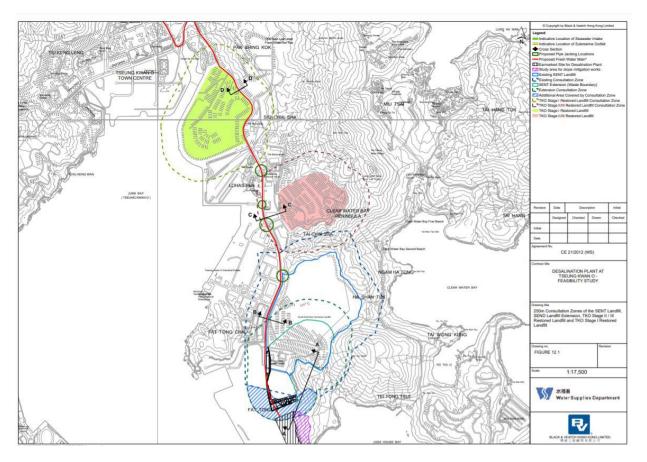
Figure 5.1 Overview of the SENT Extension Consultation Zone and the Project Site Area

The area required to be monitored for landfill gas in the reporting period is shown in **Figure 5.1**.

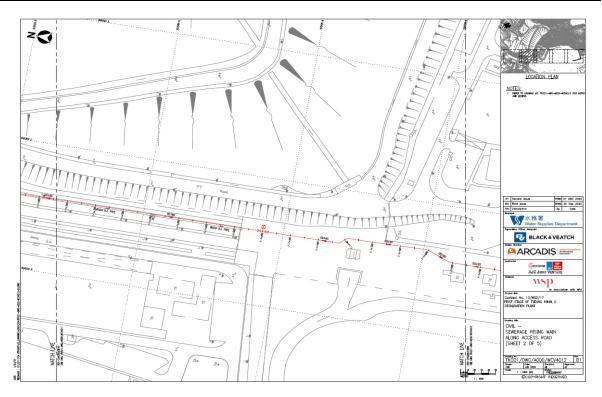
Figure 5.1 Location Map for Landfill Gas Monitoring at Wan Po Road

In this reporting period, 120 times of landfill gas monitoring were recorded at Wan Po Road (Ch700– Ch800). No exceedance of action and limit levels for methane, oxygen and carbon dioxide was observed. Monitoring was conducted during excavations at 1m depth or more within the consultation zone and whenever workers entered the excavation on the day.

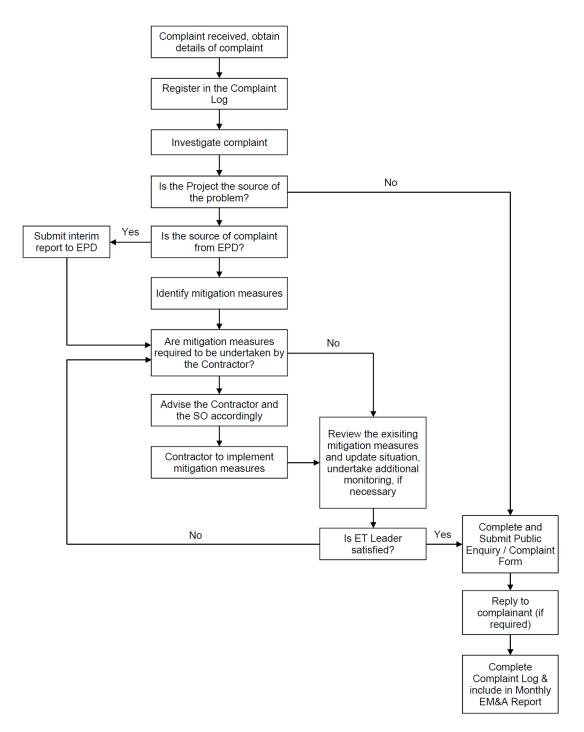
Figure 6.1 Environmental Complaint Handling Procedures

The Environmental Complaint Handling Procedure is shown in below **Figure 6.1**:

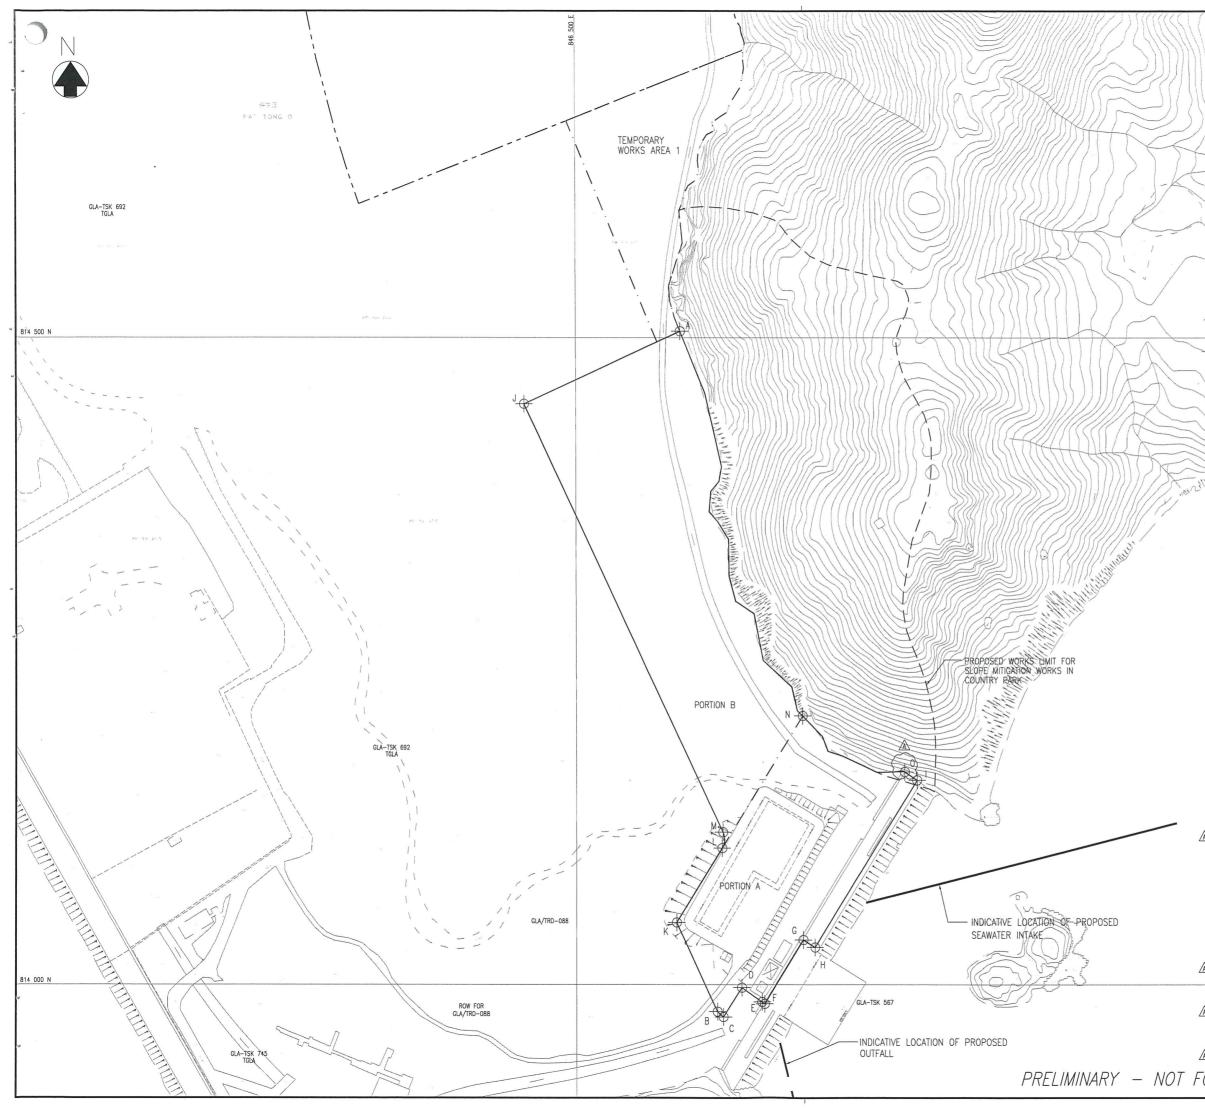
Overview of Desalination Plant in Tseung Kwan O

CODE	NAME OF BUILDING	TOTAL G.F.A. (m ²)	SITE COVERAGE (m ²)
в	COMBINE SHAFT	759.876	759.876
с	ACTIDAFF	10027.547	5455 <u>3</u> 46
G	REVERSE OSMOSIS BUILDING AND ELECTRICAL BUILDING	4511.455	5367.935
н	CO2 TANKS AREA	-	-
J	PRODUCT WATER STORAGE TANK, PUMP STATION AND ELECTRICAL BUILDING	1974.610	2933.980
к	SLUDGE TREATMENT BUILDING, TANK AND PUMP ROOM	2531.044	1228.361
М	ADMINISTRATION BUILDING & ELECTRICAL BUILDING C	2459.713	1114,062
N	MAIN ELECTRICAL AND CENTRAL CHILLER PLANT BUILDING	-	459,893
R1	ELECTROCHLORINATION BUILDING & ELECTRICAL BUILDING A	657.992	825.776
s	132 KV SUBSTATION	-	943.560
Т	IRRIGATION WATER TANK AND PUMP ROOM	-	156.148
R2	CHEMICAL BUILDING	813.056	813.056
ν	VISITOR GALLERY	1330.410	1330.410
X1	GUARD HOUSE AND FS CONTROL ROOM	39.585	39.585
X2	GUARD HOUSE	22.035	22.035
Y	R + D OUTDOOR	-	-
z	WASTE WATER TREATMENT PLANT	48.000	48.000
	TOTAL =	25175 <u>.</u> 323	21498.023
